## REPORT ON SHEAR STRENGTH TEST OF E8 ANCHOR BOLT EMBEDDED IN CRACKED CONCRETE

Client : Sunway Metal Manufactory Limited  
Project : Shear Strength Test of Anchor Bolt  
Sample Description : E8 Anchor Bolt  
Client's Sample I.D. : --

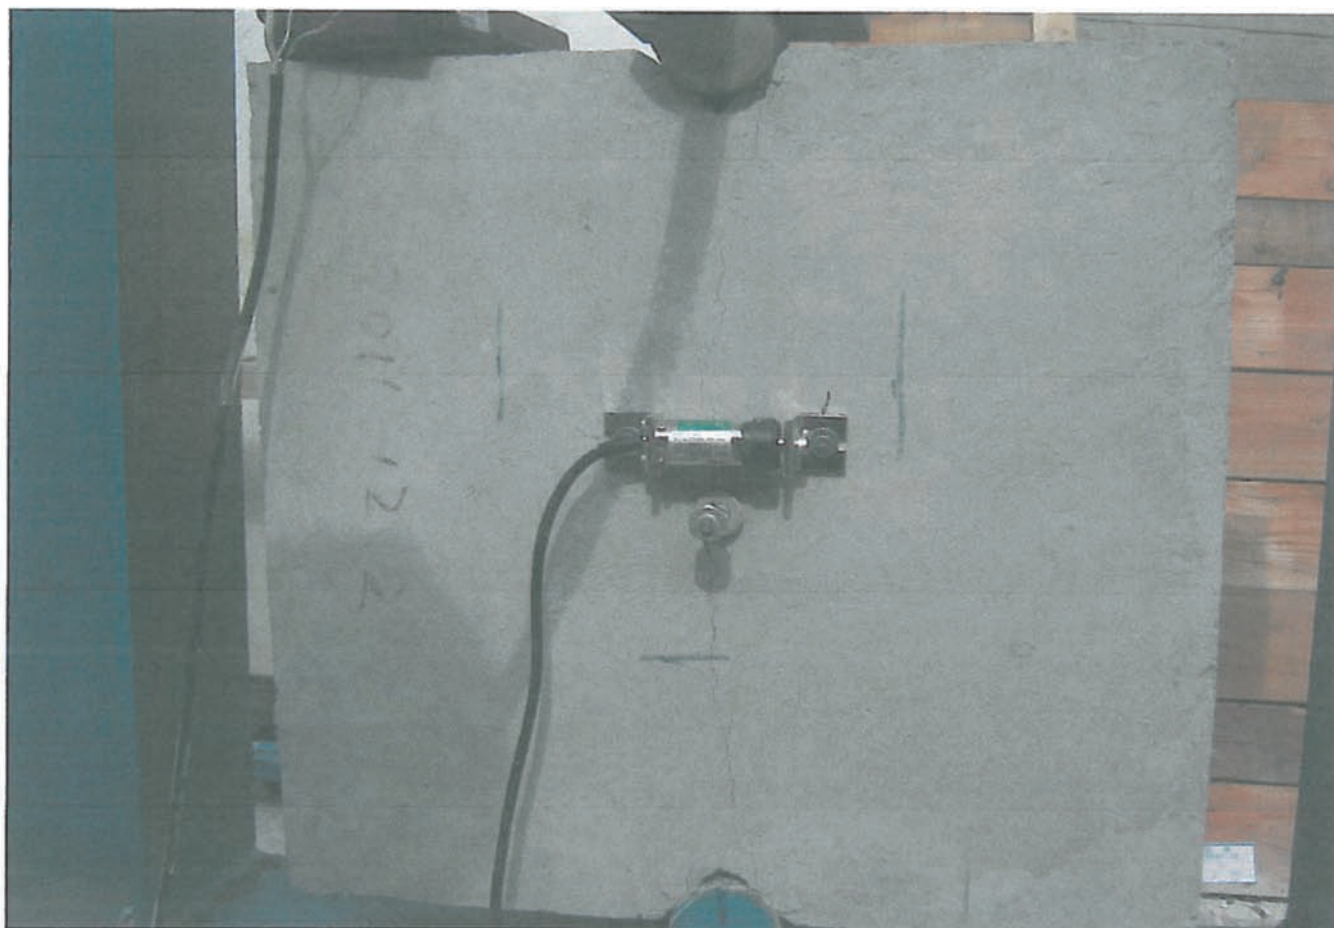
Picture 1 : The picture indicates the cracks with crack transducer positions

4. An anchor bolt shall be installed at the center of the concrete plate.
5. The cracks on the plate shall be introduced by splitting it under compressive load at both notched parts and monitored by crack transducer, which shall be positioned afar from 25 mm of the bolt center along the cracks for keeping the width of the cracks between 0.3-0.4 mm.

6. The cracks shall be ensured to pass through the anchor bolt by visual inspection. The picture is shown at picture 1.
7. The sketch of the specified concrete structure is shown at sketch 1.

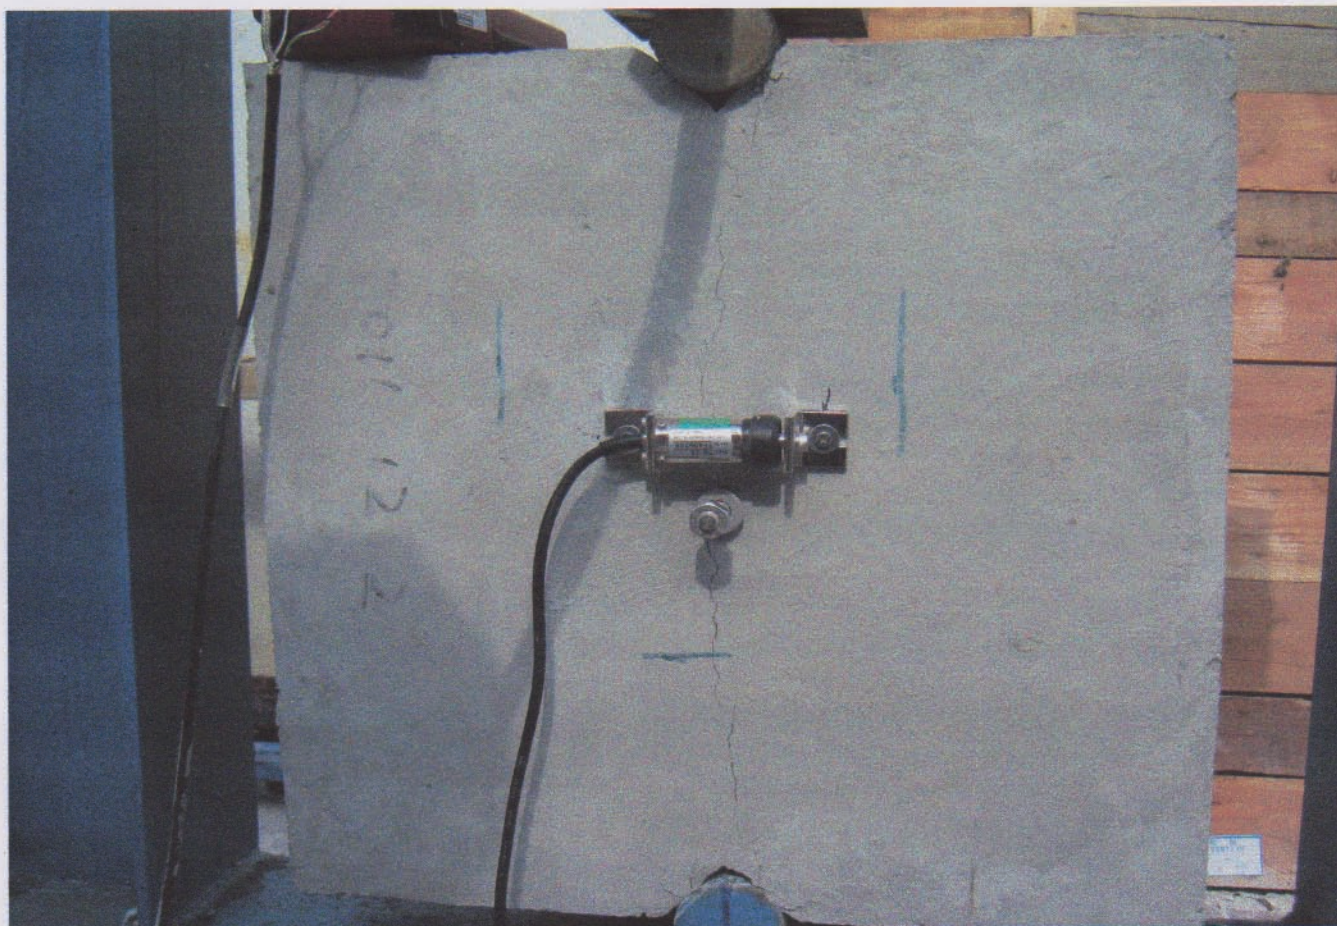
Picture 1 : The picture indicates the cracks with crack transducer positions

4. An anchor bolt shall be installed at the center of the concrete plate.
5. The cracks on the plate shall be introduced by splitting it under compressive load at both notched parts and monitored by crack transducer, which shall be positioned afar from 25 mm of the bolt center along the cracks for keeping the width of the cracks between 0.3-0.4 mm.

6. The cracks shall be ensured to pass through the anchor bolt by visual inspection. The picture is shown at picture 1.
7. The sketch of the specified concrete structure is shown at sketch 1.

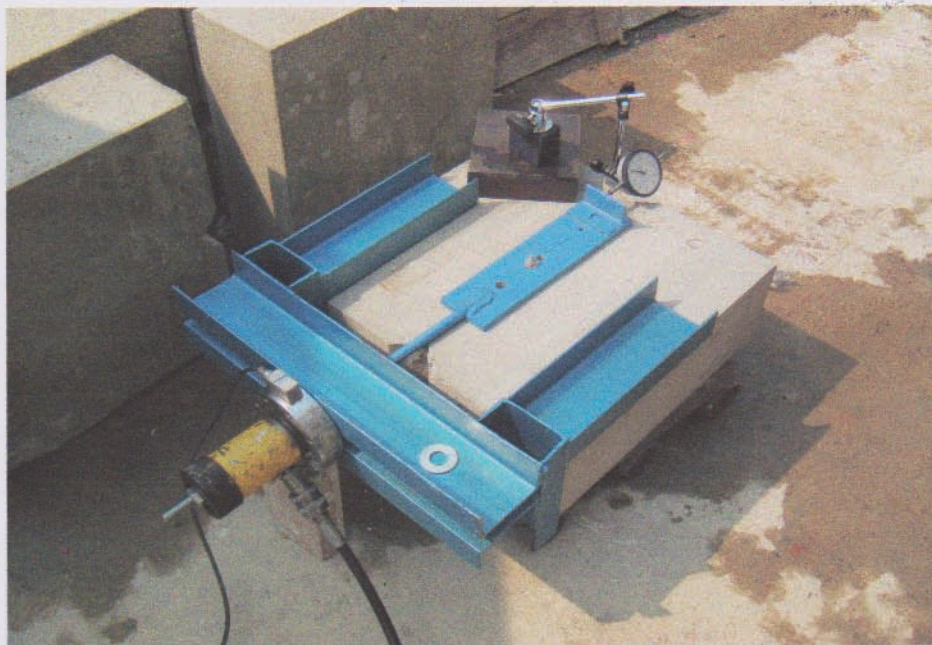
Test Configuration

- Remarks :
- 1.) The test results relate only to the samples tested.
  - 2.) The test configuration and samples after test are shown in the photographs on pages 6 to 11 of this report.
  - 3.) This report is to supersede our previous test report no. 114392ST120023.

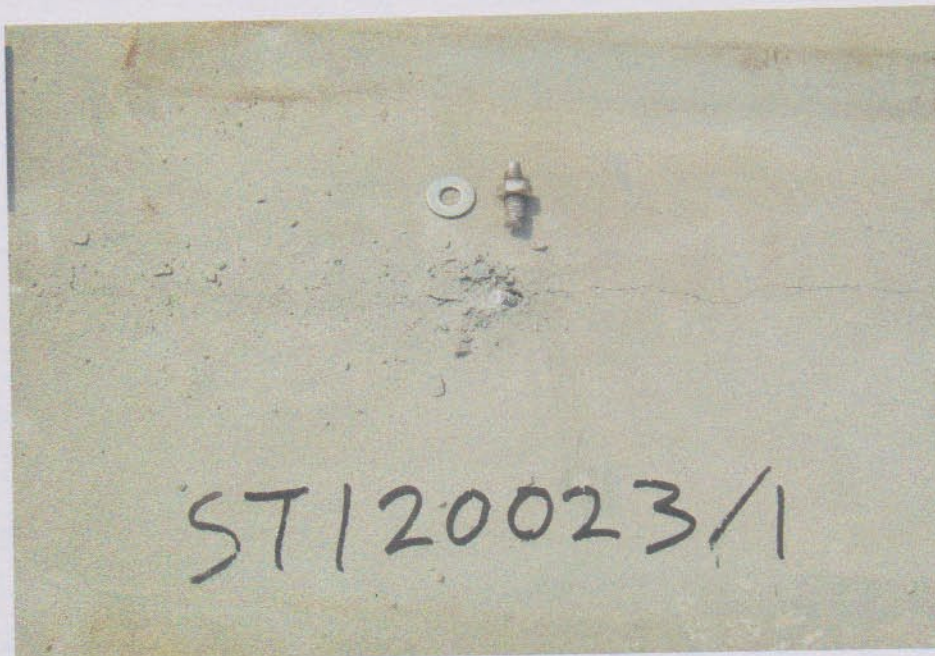
After Test  
Sample I.D. : ST120023/1

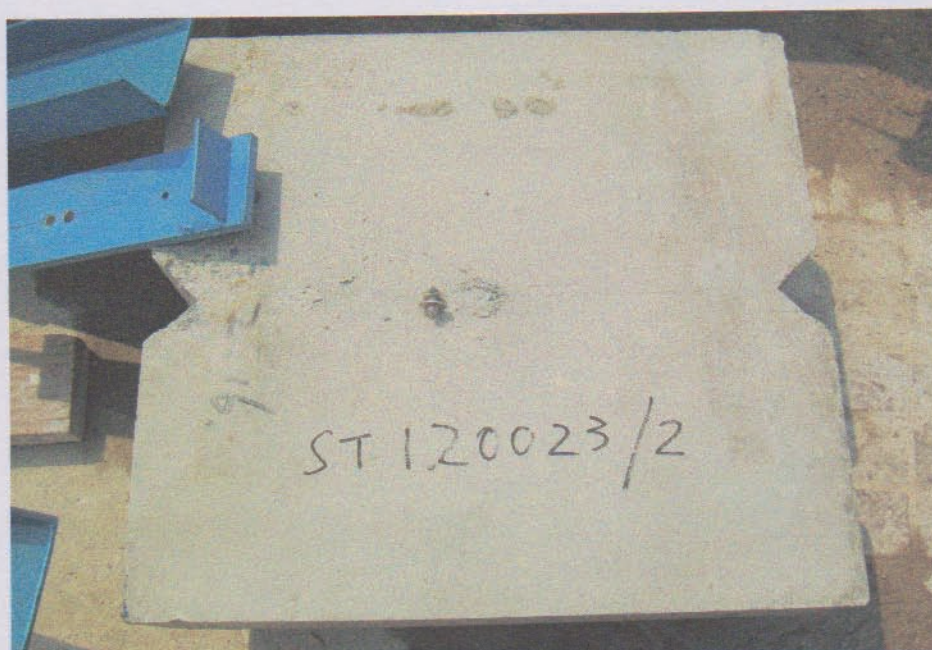
After Test  
Sample I.D. : ST120023/2

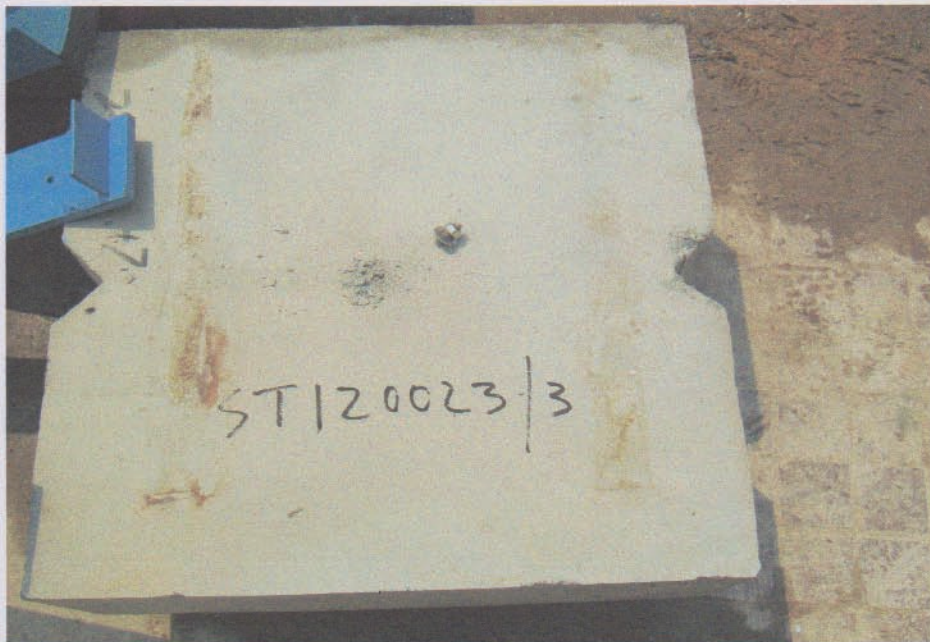
After Test  
Sample I.D. : ST120023/3

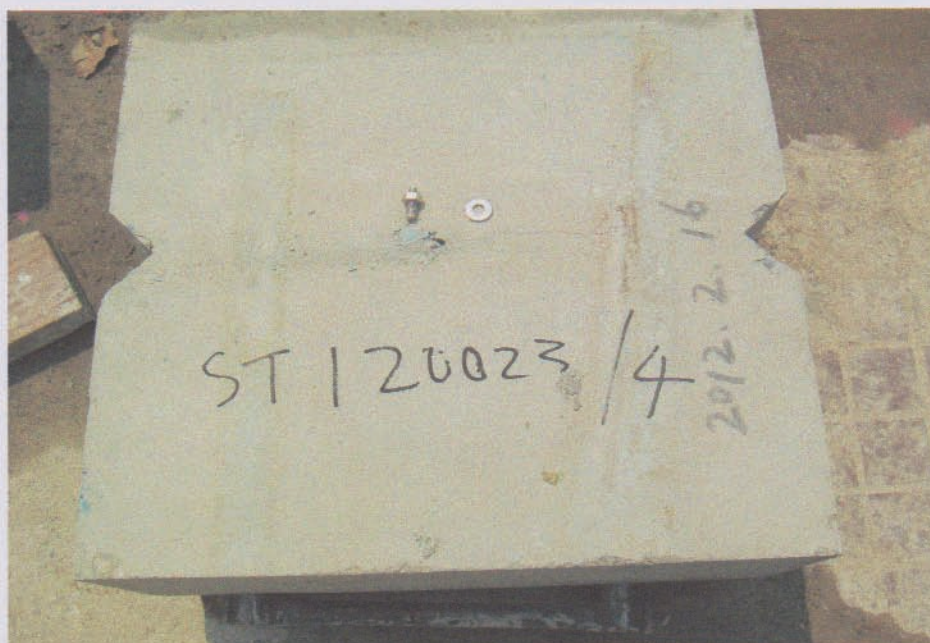
After Test  
Sample I.D. : ST120023/4

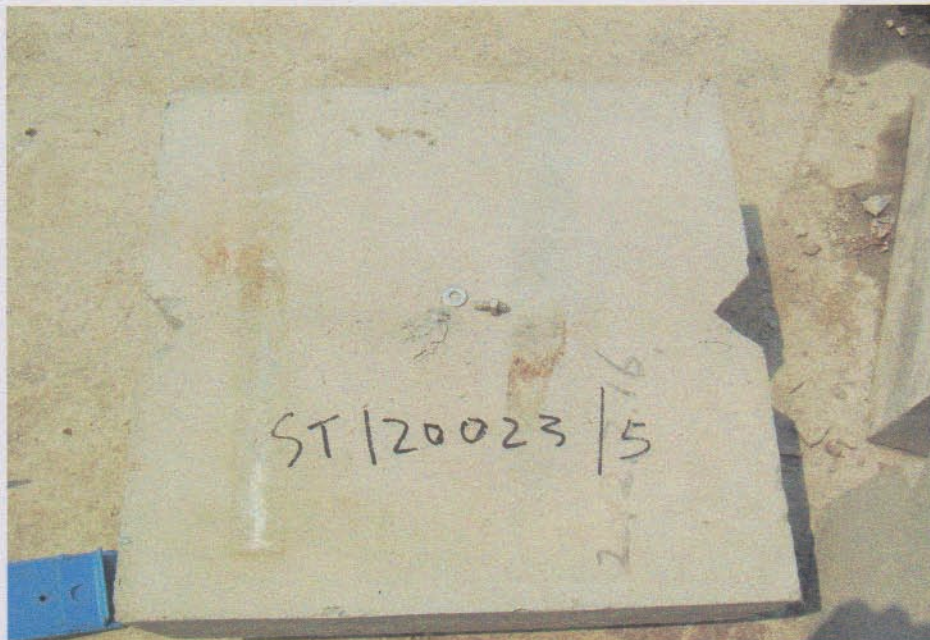
After Test  
Sample I.D. : ST120023/5

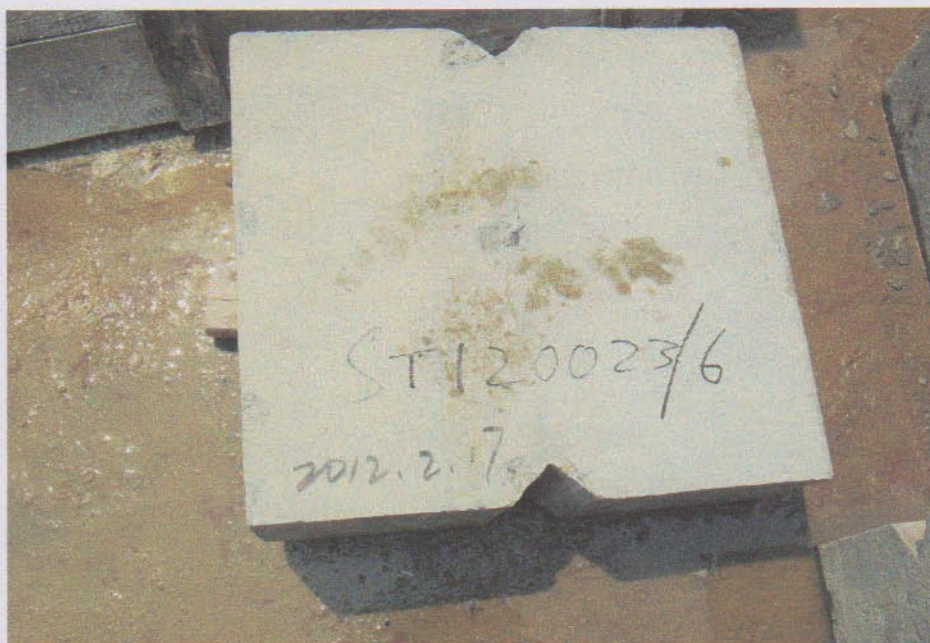
After Test  
Sample I.D. : ST120023/6

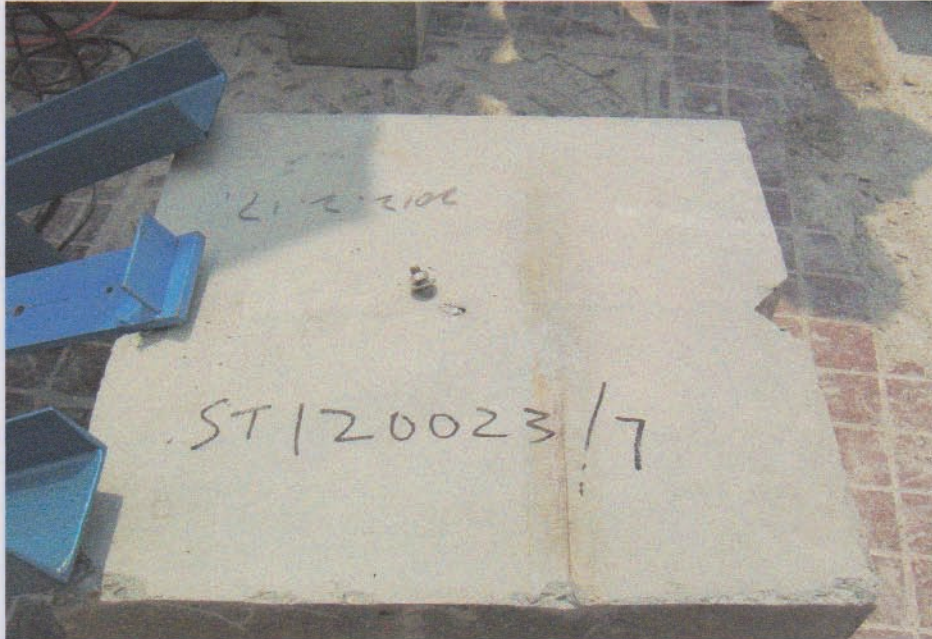
After Test  
Sample I.D. : ST120023/7

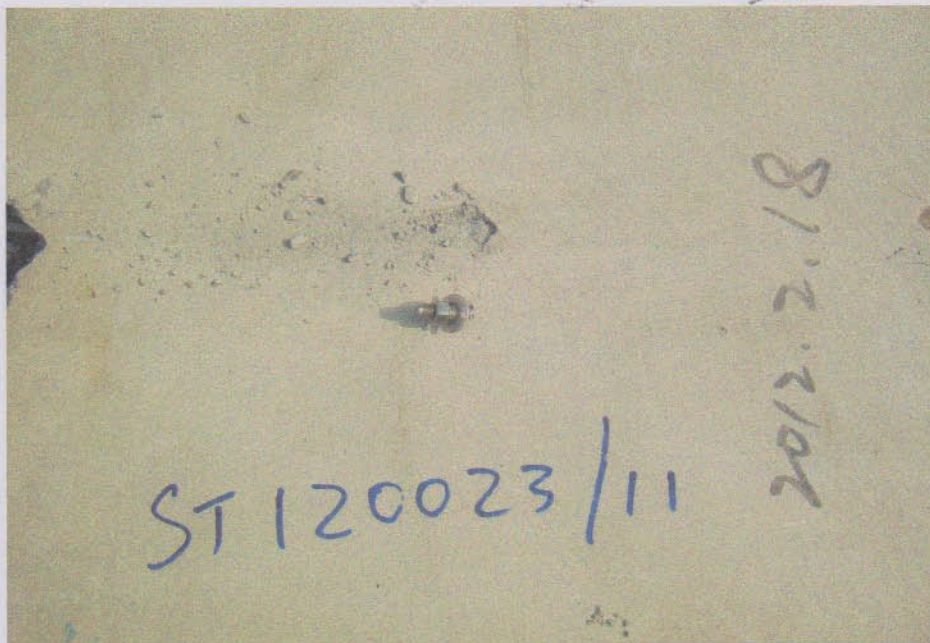
After Test  
Sample I.D. : ST120023/11

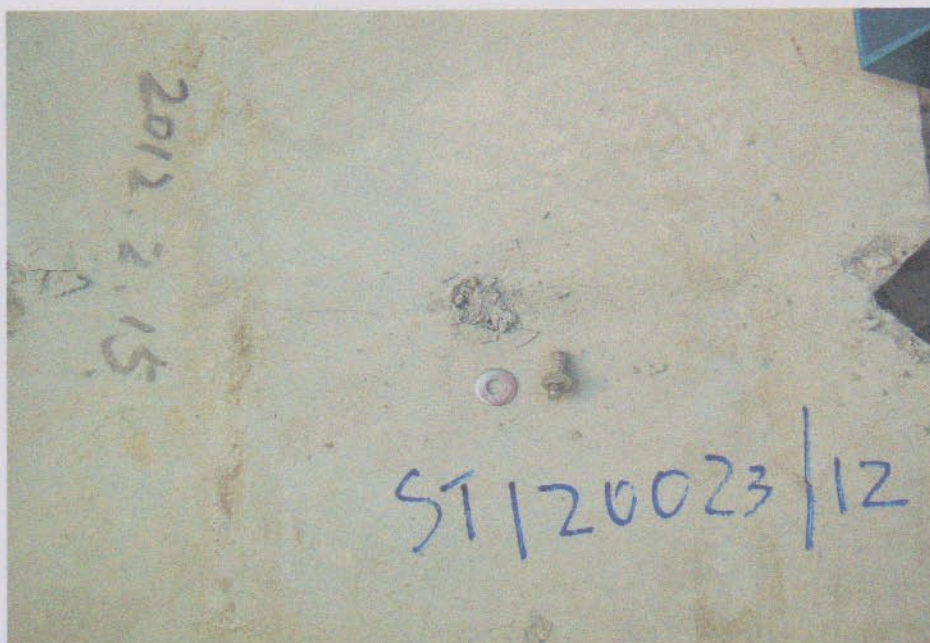
After Test  
Sample I.D. : ST120023/12
