REPORT NO GTL0812-454

## TEST REPORT

### STRENGTH OF INDIVIDUAL STONE ANCHORAGES IN DIMENSION STONE

Test Performed Strength of Individual Stone Anchorages in Dimension Stone to ASTM  
C1354-96(2004).

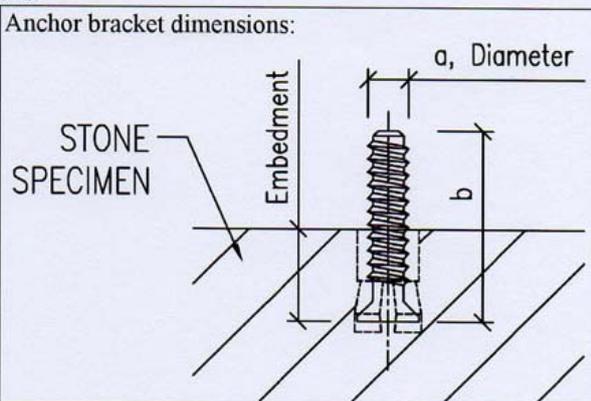
Diagram for slot, notch, hole and anchor bracket dimensions:

Sample Mark (GTL0812-454)	/01	/02	/03	/04	/05
Sample Size					
Length, mm	300	300	300	300	299
Width, mm	300	300	300	300	301
Thickness, mm	30.7	30.7	30.7	30.4	30.6
Anchor bracket dimensions:					
Dim a, mm	7.8	7.8	7.8	7.8	7.8
Dim b, mm	41	41	41	41	41
Embedment, mm	19	20	20	21	20

Slot notch or hole dimensions:	Anchor bracket dimensions:
N/A

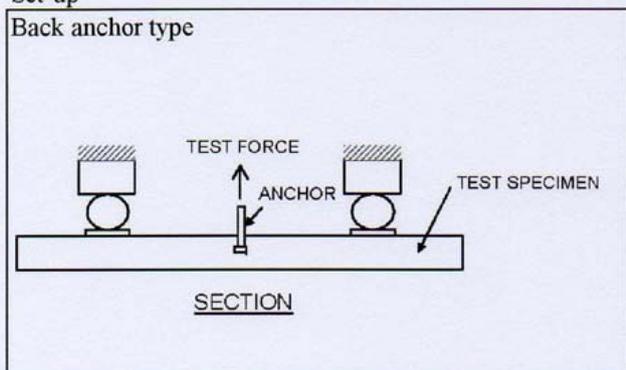
### Set-up

Ambient temperature 22 °C  
 Load rate 100 N/s

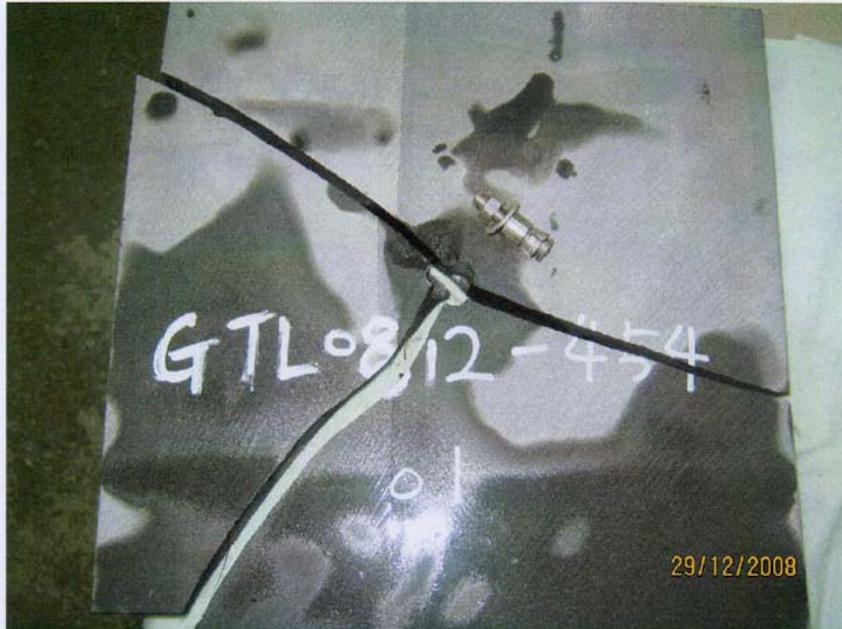
Title Anchor Test  
Sample 01  
Photo by P. Chui  
Date 2008/12/29

Sample tested after wet conditioning

Test load direction Outward

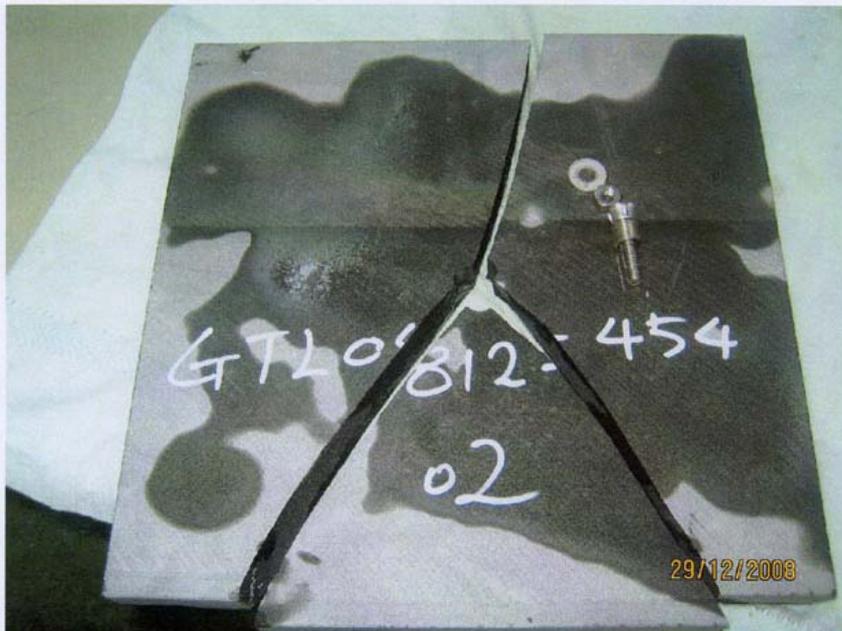
Title Anchor Test  
Sample 02  
Photo by P. Chui  
Date 2008/12/29

Sample tested after wet conditioning

Test load direction Outward

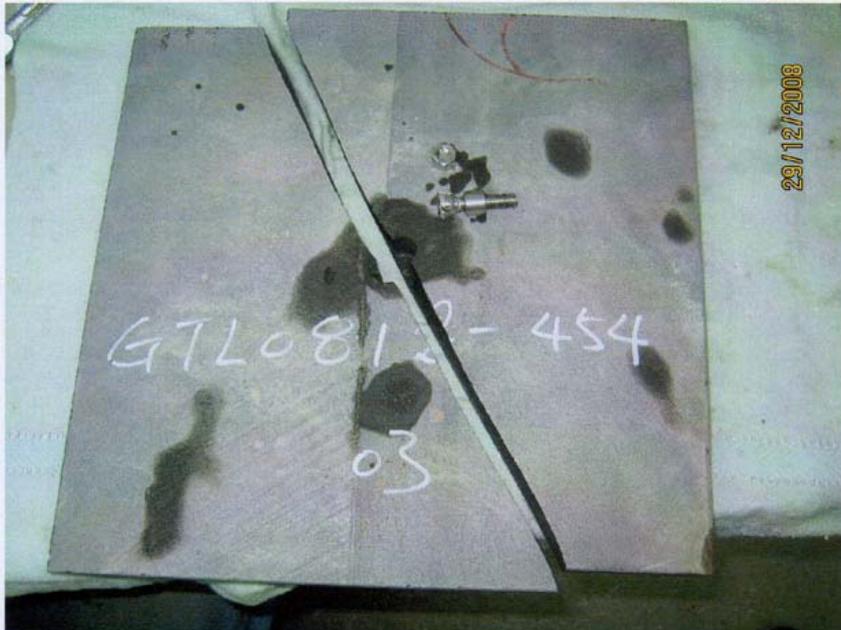
Title Anchor Test  
Sample 03  
Photo by P. Chui  
Date 2008/12/29

Sample tested after wet conditioning

Test load direction Outward

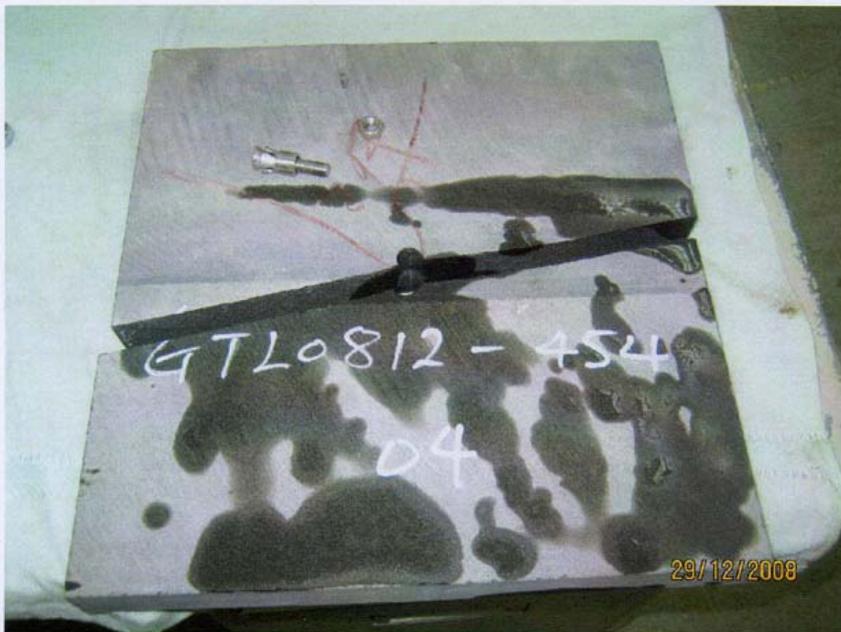
Title Anchor Test  
Sample 04  
Photo by P. Chui  
Date 2008/12/29

Sample tested after wet conditioning

Test load direction Outward

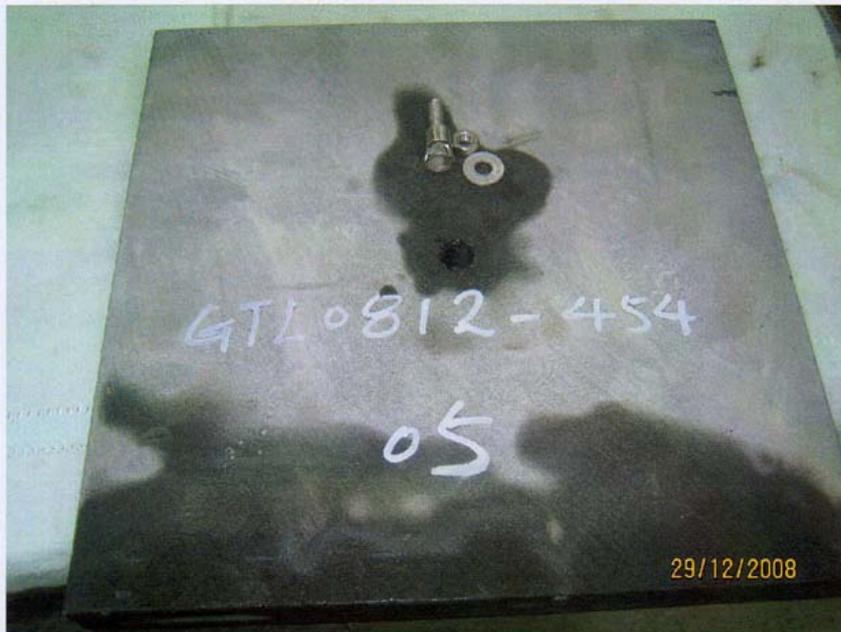
Title Anchor Test  
Sample 05  
Photo by P. Chui  
Date 2008/12/29

Sample tested after wet  
conditioning

Test load direction Outward
