REPORT ON SHEAR STRENGTH TEST OF E10 ANCHOR BOLT EMBEDDED IN NON-CRACKED CONCRETE

REPORT ON THE SHEAR LOAD TEST OF ANCHOR BOLT

Project : Testing of Anchor Bolt SW-E10

Report No. : 092660ST90534(1)

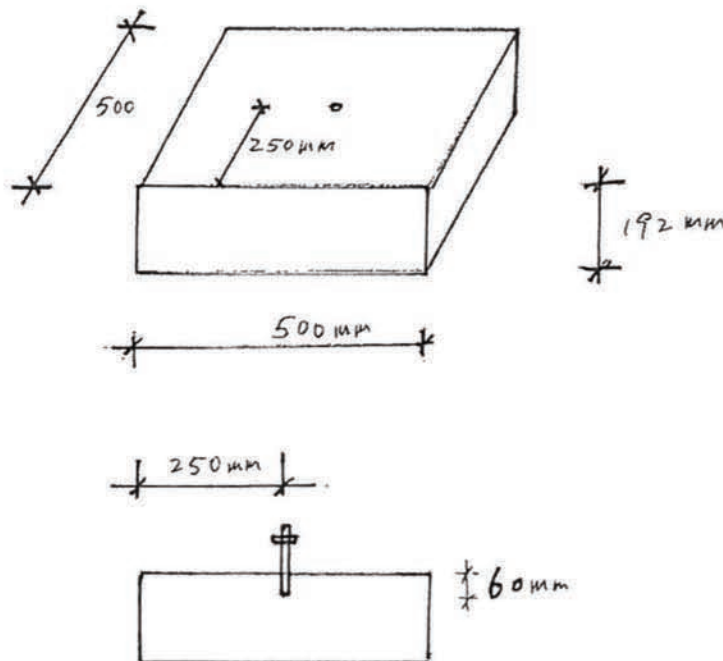
Sketch 1 : The specified concrete structure

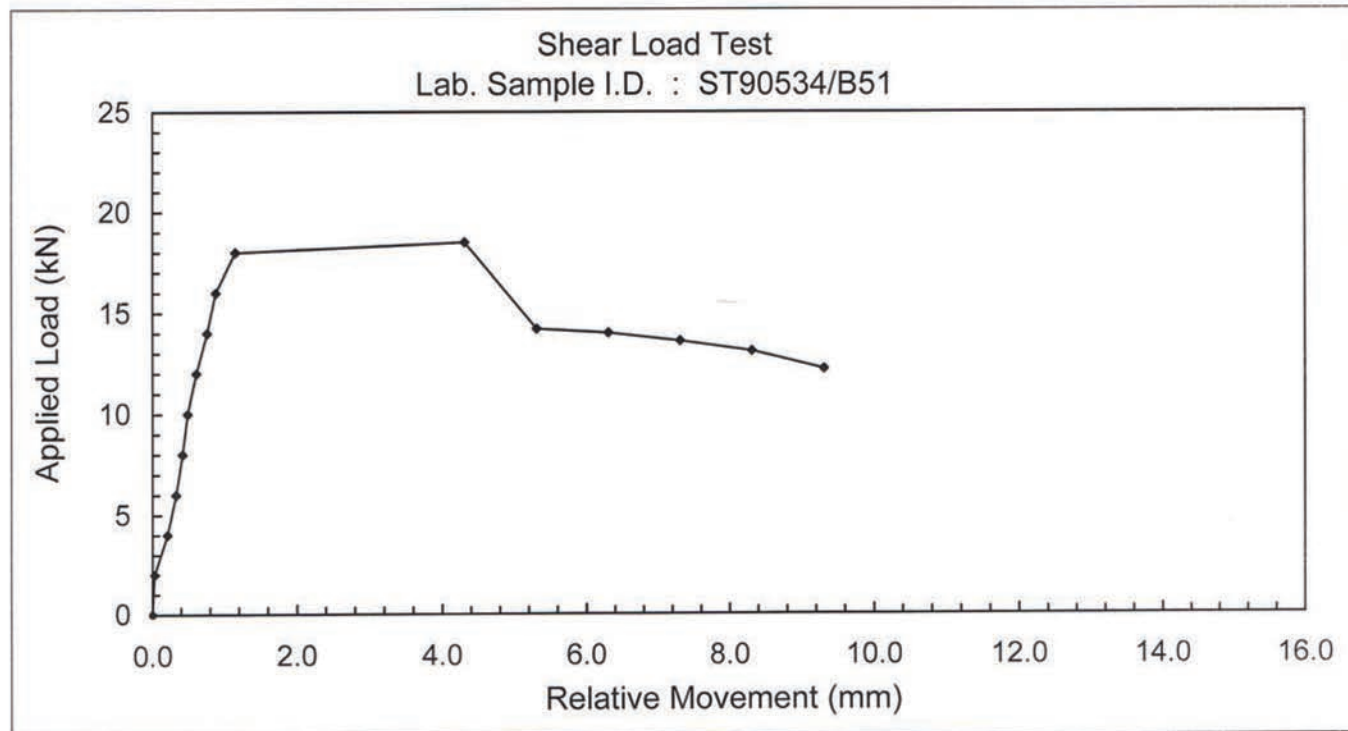
Lab. Sample I.D. : ST90534/B51

Applied Load (kN)	Relative Movement (mm)	Applied Load (kN)	Relative Movement (mm)
0	0	16.0	0.88
2.0	0.03	18.0	1.15
4.0	0.21	18.5	4.31
6.0	0.33	14.2	5.31
8.0	0.42	14.0	6.31
10.0	0.49	13.6	7.31
12.0	0.61	13.1	8.31
14.0	0.76	12.2	9.31

Observation: Failure of concrete & deformation of anchor bolt was noted at the applied load of 18.5 kN.

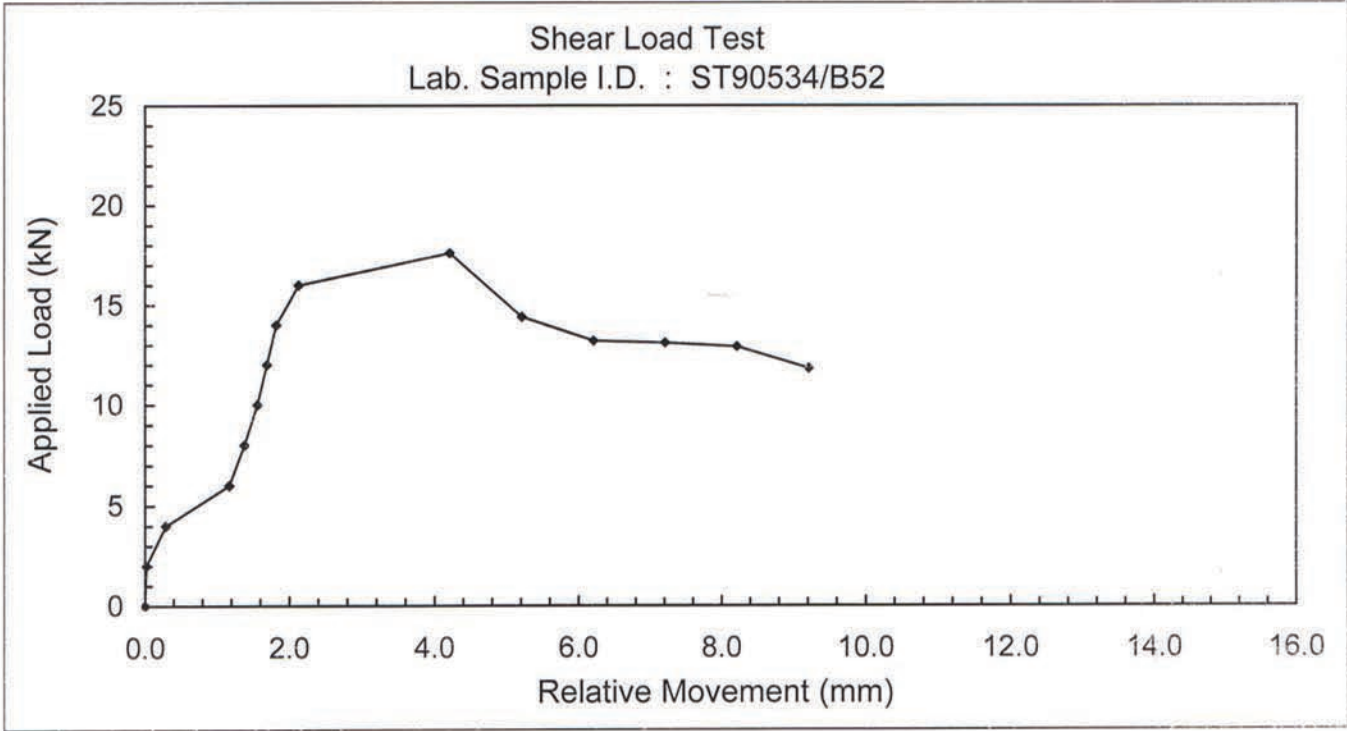
Lab. Sample I.D. : ST90534/B52 Date Tested : 10 February 2010

Applied Load (kN)	Relative Movement (mm)	Applied Load (kN)	Relative Movement (mm)
0	0	16.0	2.13
2.0	0.02	17.6	4.21
4.0	0.29	14.4	5.21
6.0	1.17	13.2	6.21
8.0	1.38	13.1	7.21
10.0	1.56	12.9	8.21
12.0	1.69	11.8	9.21
14.0	1.82

Observation: Failure of concrete & deformation of anchor bolt was noted at the applied load of 17.6 kN.

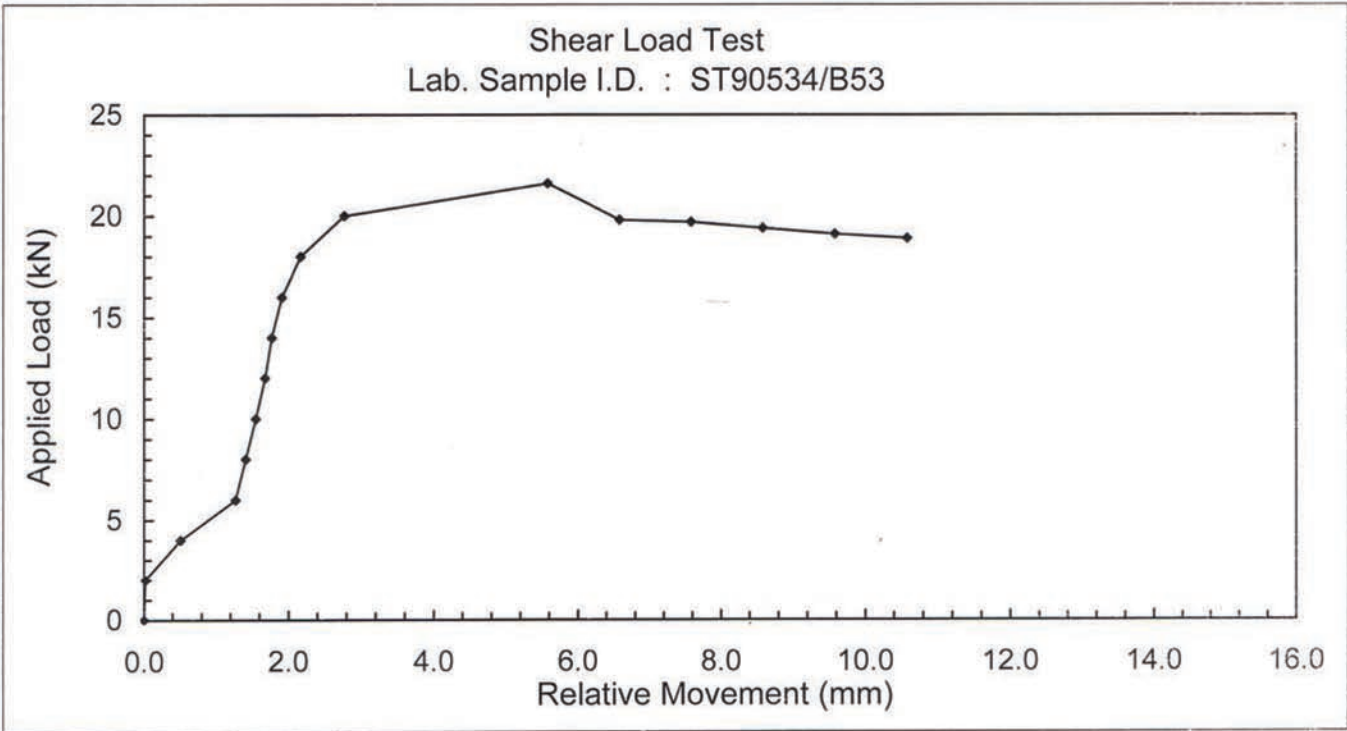
Lab. Sample I.D. : ST90534/B53 Date Tested : 10 February 2010

Applied Load (kN)	Relative Movement (mm)	Applied Load (kN)	Relative Movement (mm)
0	0	18.0	2.17
2.0	0.02	20.0	2.77
4.0	0.51	21.6	5.58
6.0	1.27	19.8	6.58
8.0	1.41	19.7	7.58
10.0	1.55	19.4	8.58
12.0	1.68	19.1	9.58
14.0	1.77	18.9	10.58
16.0	1.91

Observation: Failure of concrete & deformation of anchor bolt was noted at the applied load of 21.6 kN.

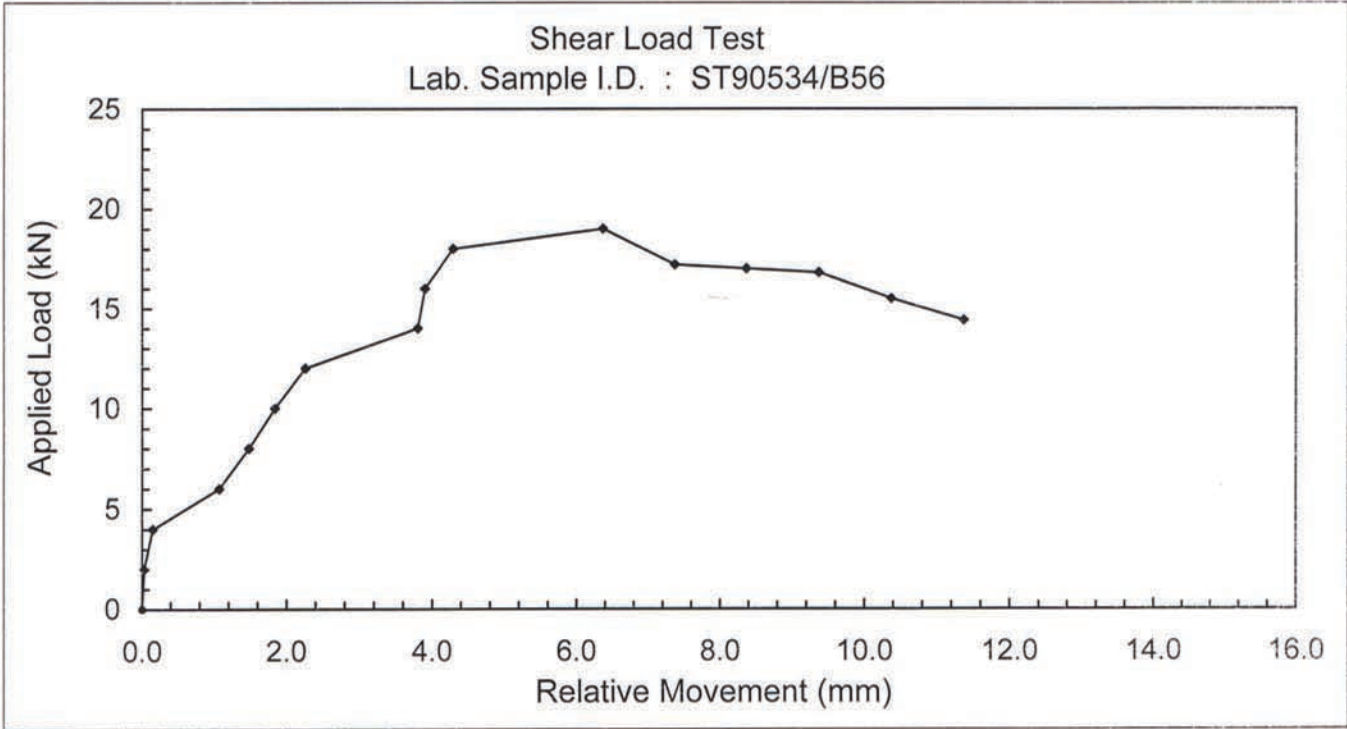
Lab. Sample I.D. : ST90534/B56 Date Tested : 10 February 2010

Applied Load (kN)	Relative Movement (mm)	Applied Load (kN)	Relative Movement (mm)
0	0	16.0	3.90
2.0	0.03	18.0	4.29
4.0	0.15	19.0	6.37
6.0	1.07	17.2	7.37
8.0	1.48	17.0	8.37
10.0	1.84	16.8	9.37
12.0	2.26	15.5	10.37
14.0	3.80	14.4	11.37

Observation: Failure of concrete & deformation of anchor bolt was noted at the applied load of 19.0 kN.

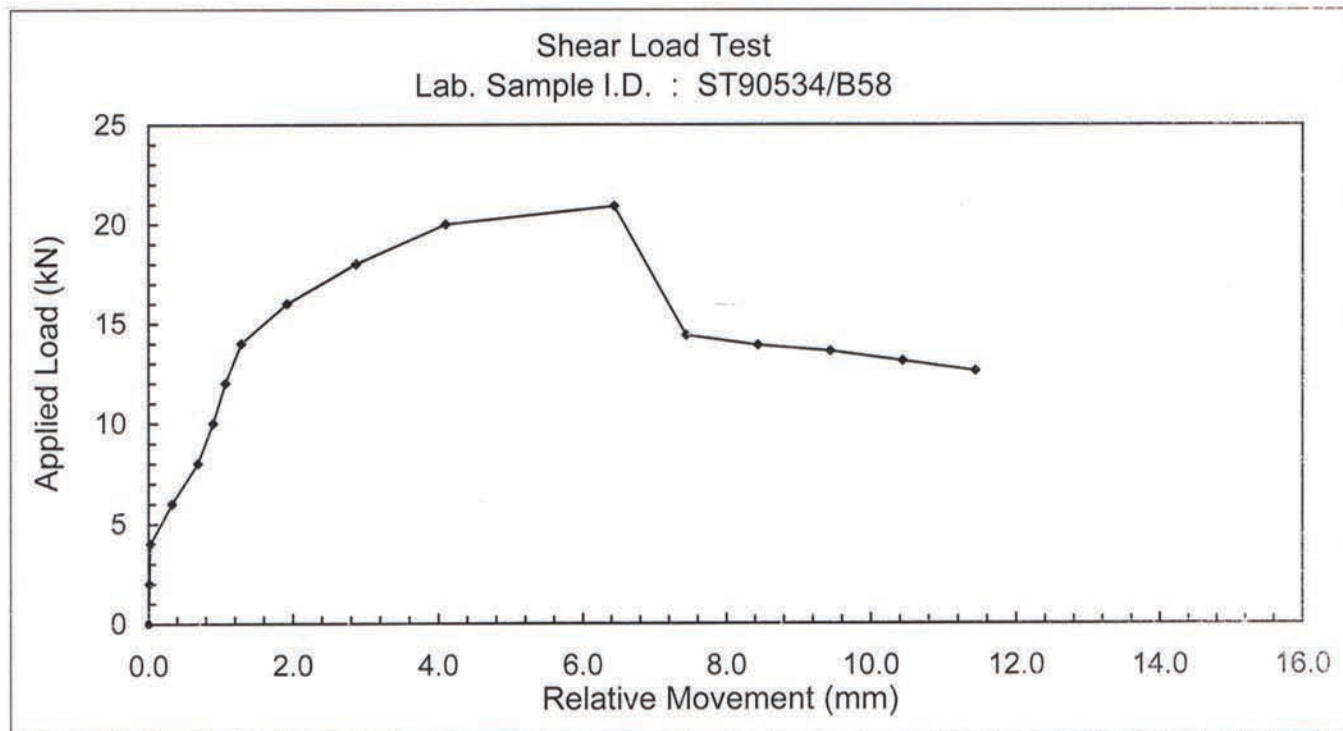
Lab. Sample I.D. : ST90534/B58

Applied Load (kN)	Relative Movement (mm)	Applied Load (kN)	Relative Movement (mm)
0	0	18.0	2.87
2.0	0.01	20.0	4.10
4.0	0.03	20.9	6.44
6.0	0.33	14.4	7.44
8.0	0.69	13.9	8.44
10.0	0.90	13.6	9.44
12.0	1.07	13.1	10.44
14.0	1.29	12.6	11.44
16.0	1.92

Observation: Failure of concrete & deformation of anchor bolt was noted at the applied load of 20.9 kN.

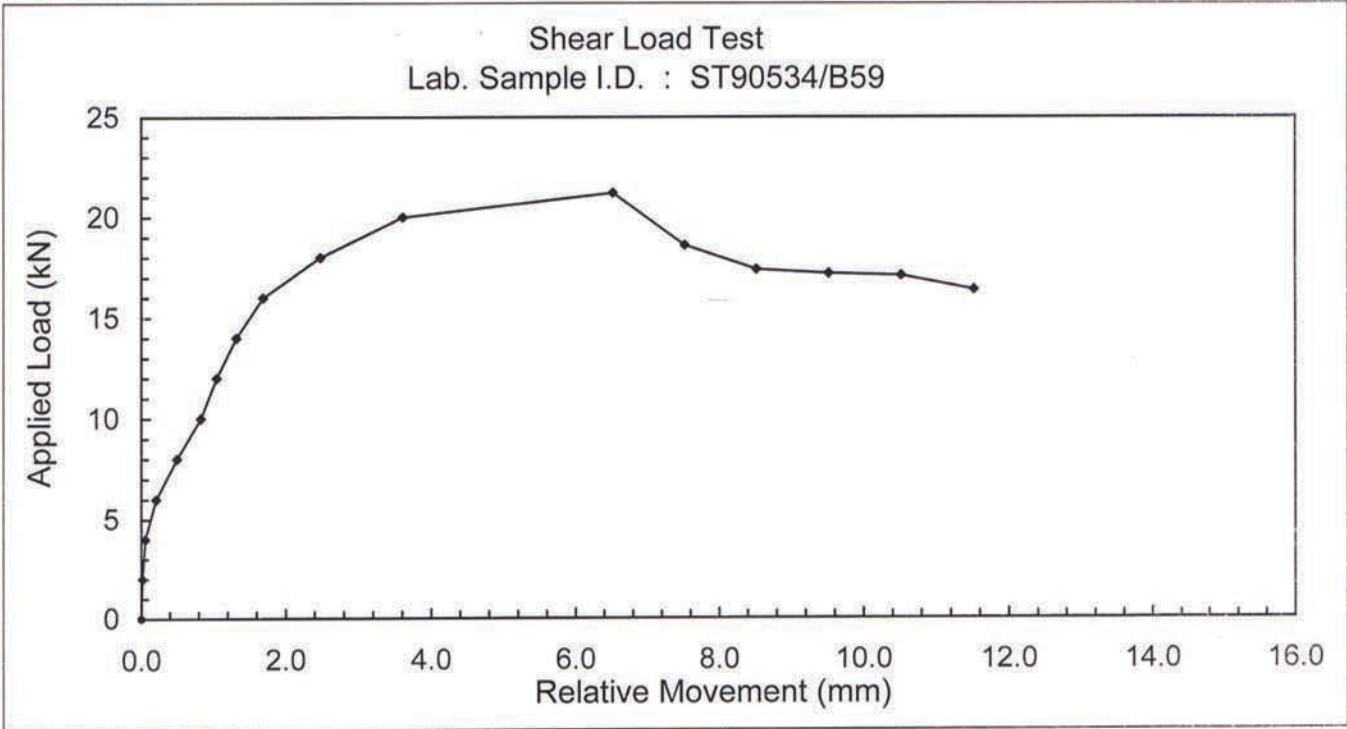
Lab. Sample I.D. : ST90534/B59 Date Tested : 10 February 2010

Applied Load (kN)	Relative Movement (mm)	Applied Load (kN)	Relative Movement (mm)
0	0	18.0	2.48
2.0	0.02	20.0	3.61
4.0	0.06	21.2	6.52
6.0	0.21	18.6	7.52
8.0	0.50	17.4	8.52
10.0	0.83	17.2	9.52
12.0	1.05	17.1	10.52
14.0	1.32	16.4	11.52
16.0	1.69

Observation: Failure of concrete & deformation of anchor bolt was noted at the applied load of 21.2 kN.

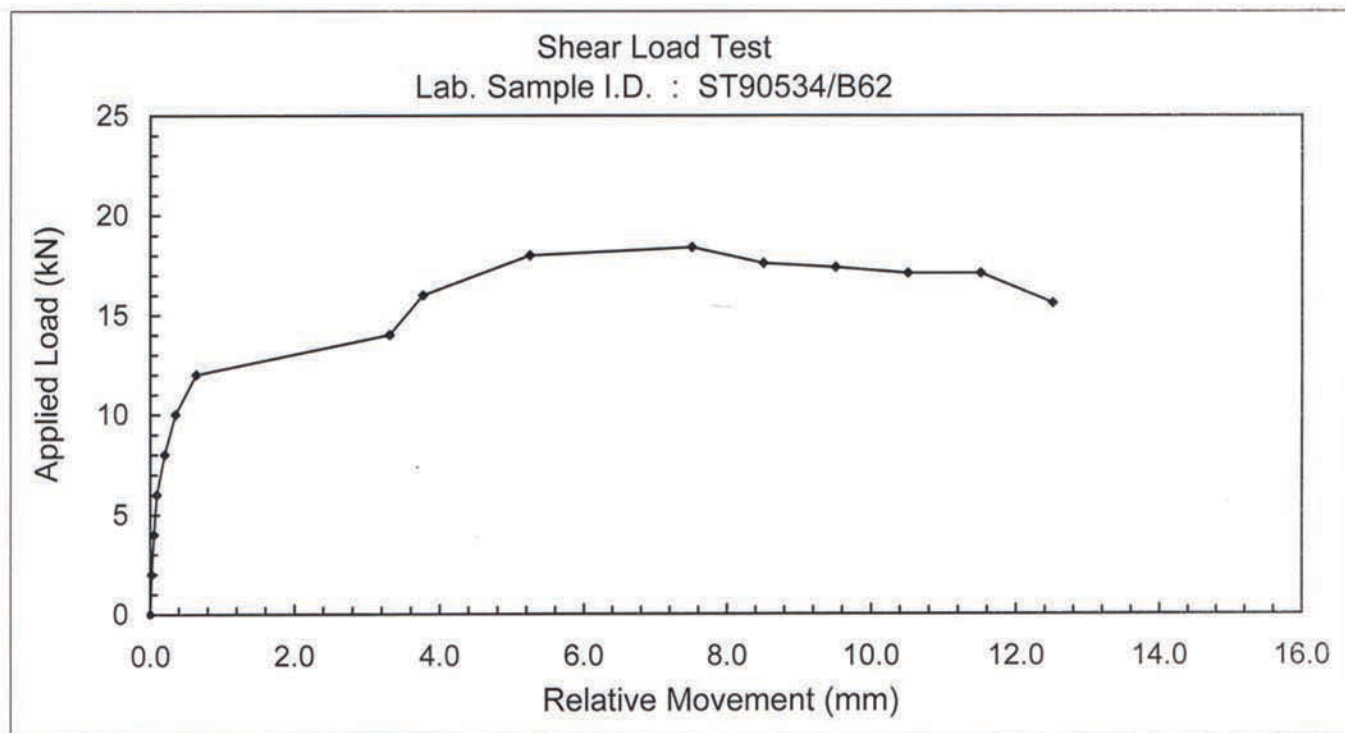
Lab. Sample I.D. : ST90534/B62

Applied Load (kN)	Relative Movement (mm)	Applied Load (kN)	Relative Movement (mm)
0	0	16.0	3.77
2.0	0.02	18.0	5.25
4.0	0.05	18.4	7.51
6.0	0.09	17.6	8.51
8.0	0.20	17.4	9.51
10.0	0.35	17.1	10.51
12.0	0.64	17.1	11.51
14.0	3.31	15.6	12.51

Observation: Failure of concrete & deformation of anchor bolt was noted at the applied load of 18.4 kN.

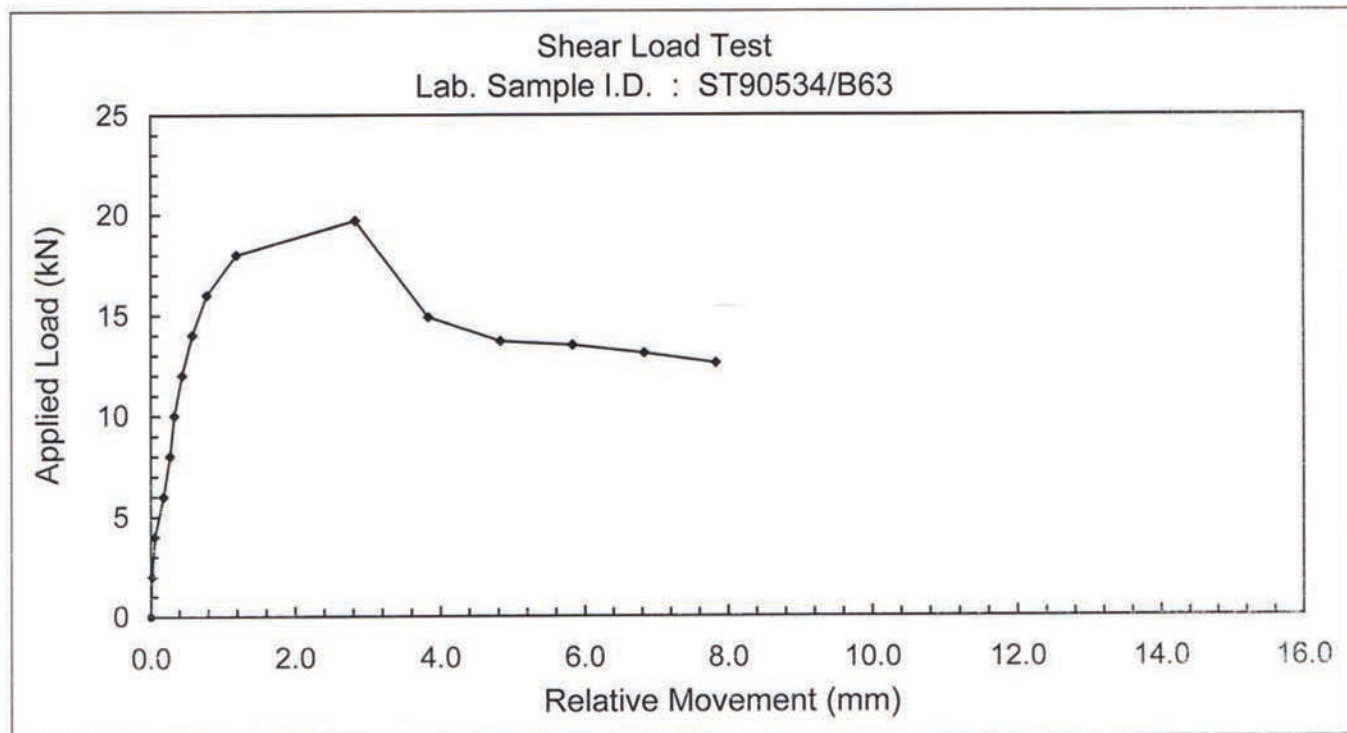
Lab. Sample I.D. : ST90534/B63

Applied Load (kN)	Relative Movement (mm)	Applied Load (kN)	Relative Movement (mm)
0	0	16.0	0.78
2.0	0.02	18.0	1.19
4.0	0.06	19.7	2.83
6.0	0.18	14.9	3.83
8.0	0.27	13.7	4.83
10.0	0.33	13.5	5.83
12.0	0.44	13.1	6.83
14.0	0.58	12.6	7.83

Observation: Failure of concrete & deformation of anchor bolt was noted at the applied load of 19.7 kN.

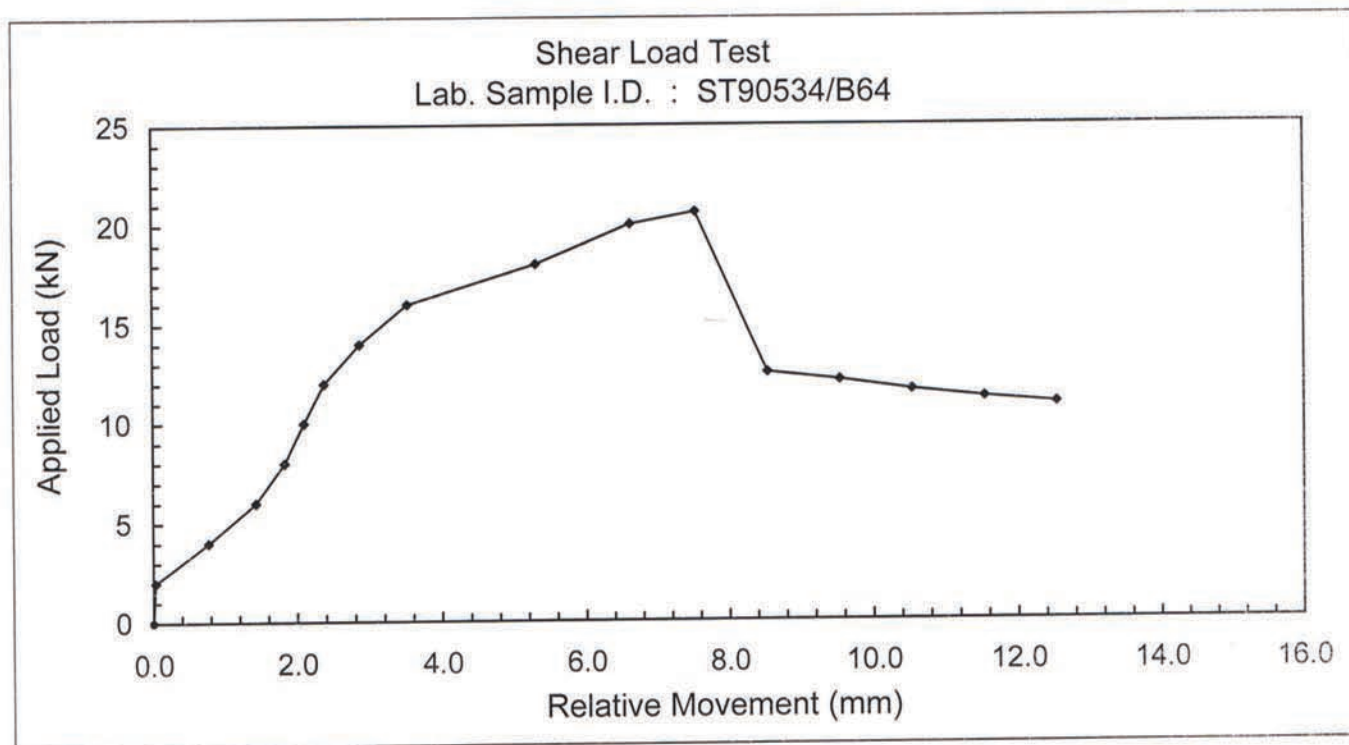
Lab. Sample I.D. : ST90534/B64

Applied Load (kN)	Relative Movement (mm)	Applied Load (kN)	Relative Movement (mm)
0	0	18.0	5.31
2.0	0.03	20.0	6.63
4.0	0.77	20.6	7.54
6.0	1.43	12.5	8.54
8.0	1.83	12.1	9.54
10.0	2.10	11.6	10.54
12.0	2.38	11.2	11.54
14.0	2.87	10.9	12.54
16.0	3.53

Observation: Failure of concrete & deformation of anchor bolt was noted at the applied load of 20.6 kN.

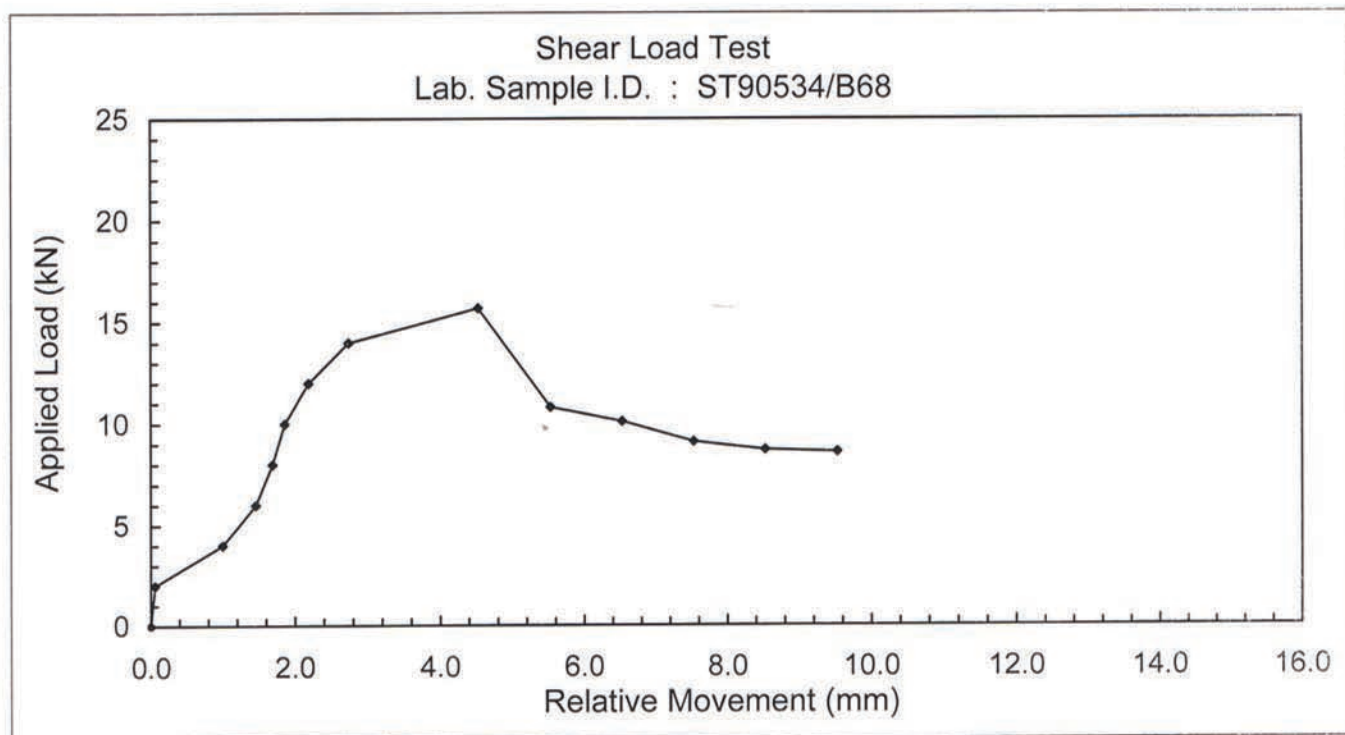
Lab. Sample I.D. : ST90534/B68

Applied Load (kN)	Relative Movement (mm)	Applied Load (kN)	Relative Movement (mm)
0	0	14.0	2.74
2.0	0.06	15.7	4.53
4.0	1.00	10.8	5.53
6.0	1.46	10.1	6.53
8.0	1.69	9.1	7.53
10.0	1.86	8.7	8.53
12.0	2.19	8.6	9.53

Observation: Failure of concrete & deformation of anchor bolt was noted at the applied load of 15.7 kN.

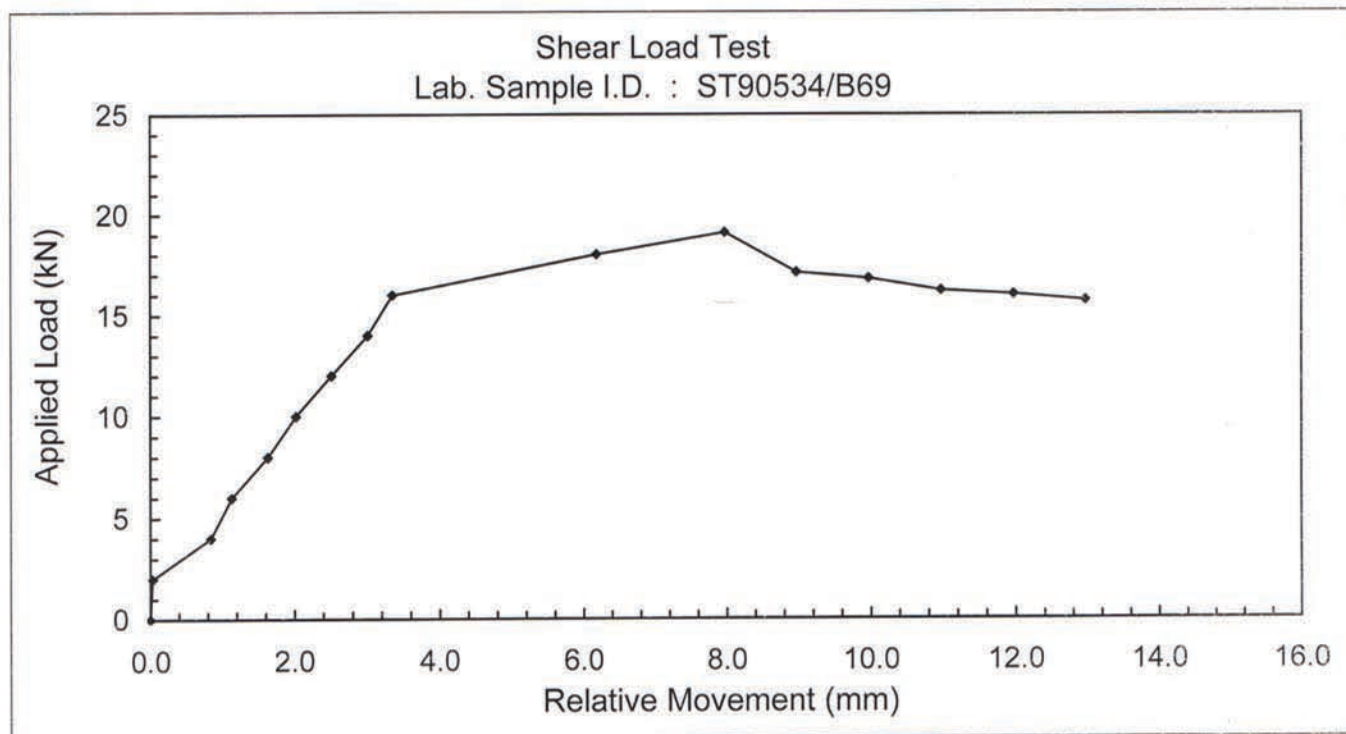
Lab. Sample I.D. : ST90534/B69

Applied Load (kN)	Relative Movement (mm)	Applied Load (kN)	Relative Movement (mm)
0	0	16.0	3.35
2.0	0.03	18.0	6.18
4.0	0.84	19.1	7.97
6.0	1.13	17.1	8.97
8.0	1.63	16.8	9.97
10.0	2.02	16.2	10.97
12.0	2.51	16.0	11.97
14.0	3.01	15.7	12.97

Observation: Failure of concrete & deformation of anchor bolt was noted at the applied load of 19.1 kN.

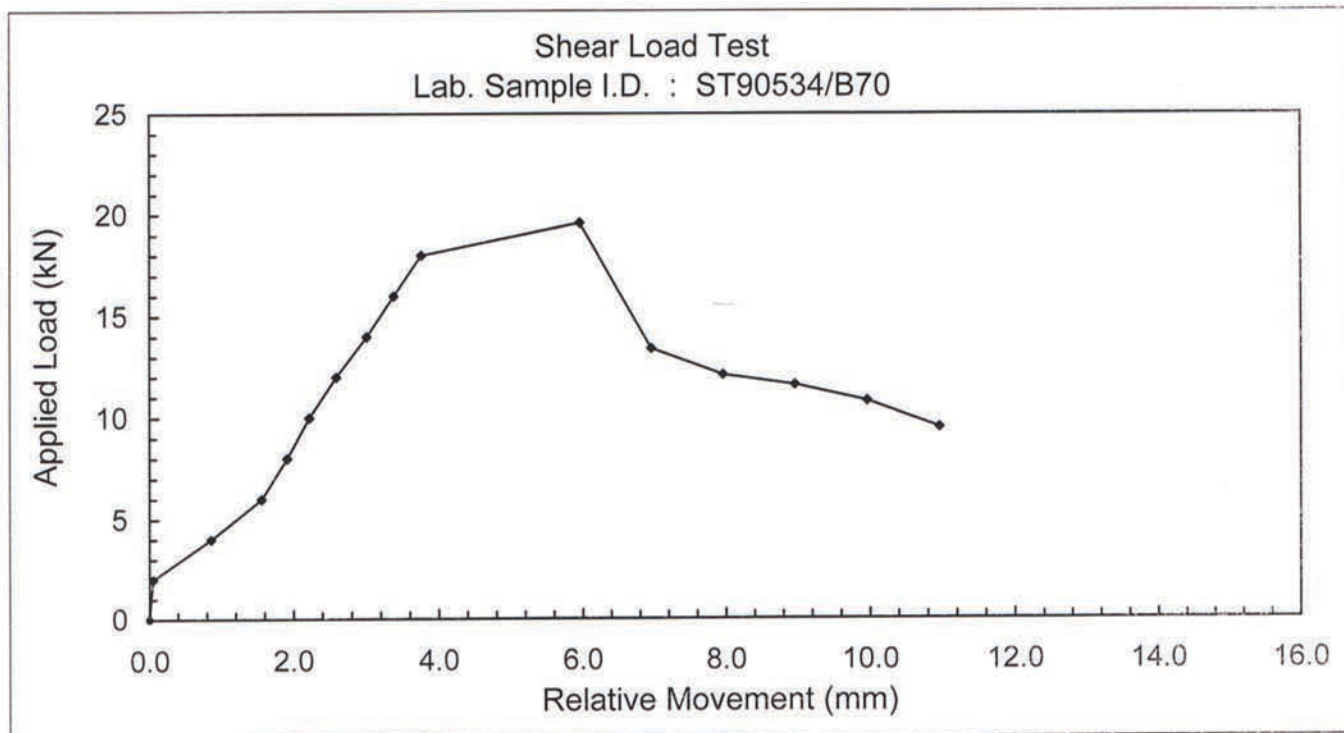
Lab. Sample I.D. : ST90534/B70

Applied Load (kN)	Relative Movement (mm)	Applied Load (kN)	Relative Movement (mm)
0	0	16.0	3.38
2.0	0.05	18.0	3.76
4.0	0.86	19.6	5.96
6.0	1.56	13.4	6.96
8.0	1.91	12.1	7.96
10.0	2.22	11.6	8.96
12.0	2.59	10.8	9.96
14.0	3.01	9.5	10.96

Observation: Failure of concrete & deformation of anchor bolt was noted at the applied load of 19.6 kN.

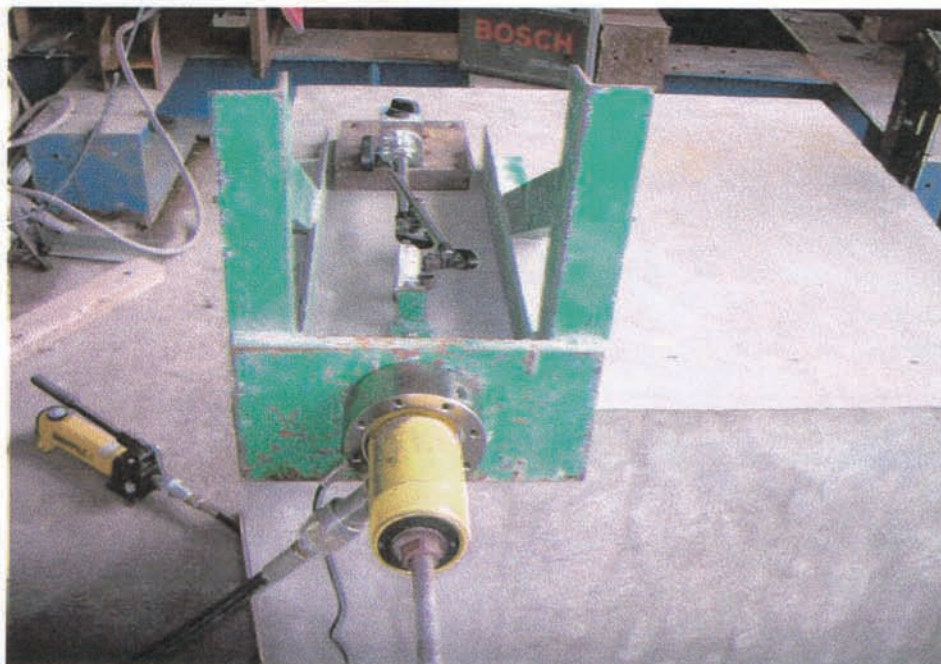
Test Configuration
Sample I.D. : ST90534/B51-B70

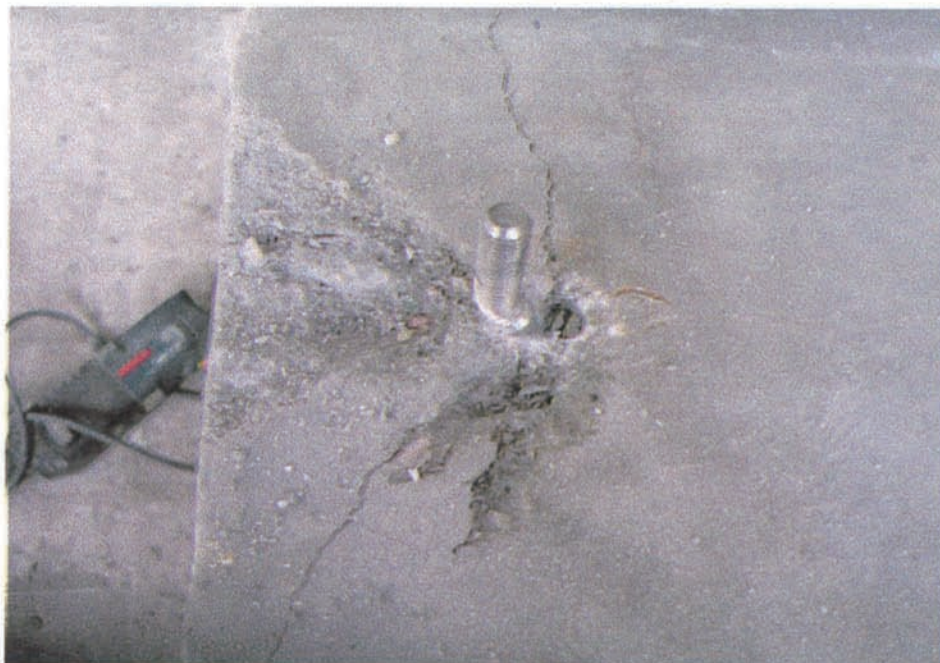
After Test
Sample I.D. : ST90534/B51

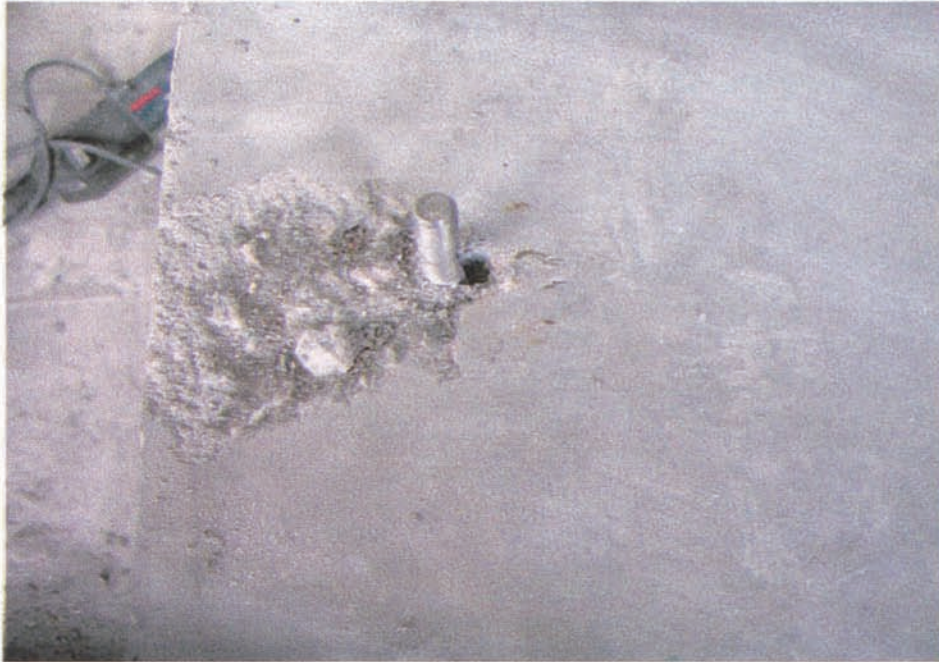
After Test
Sample I.D. : ST90534/B52

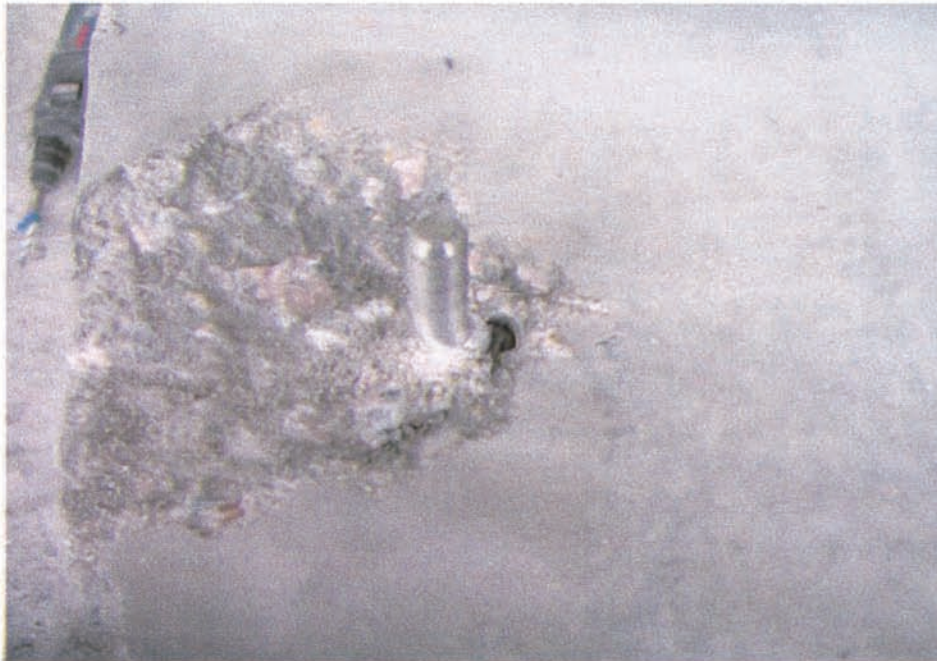
After Test
Sample I.D. : ST90534/B53

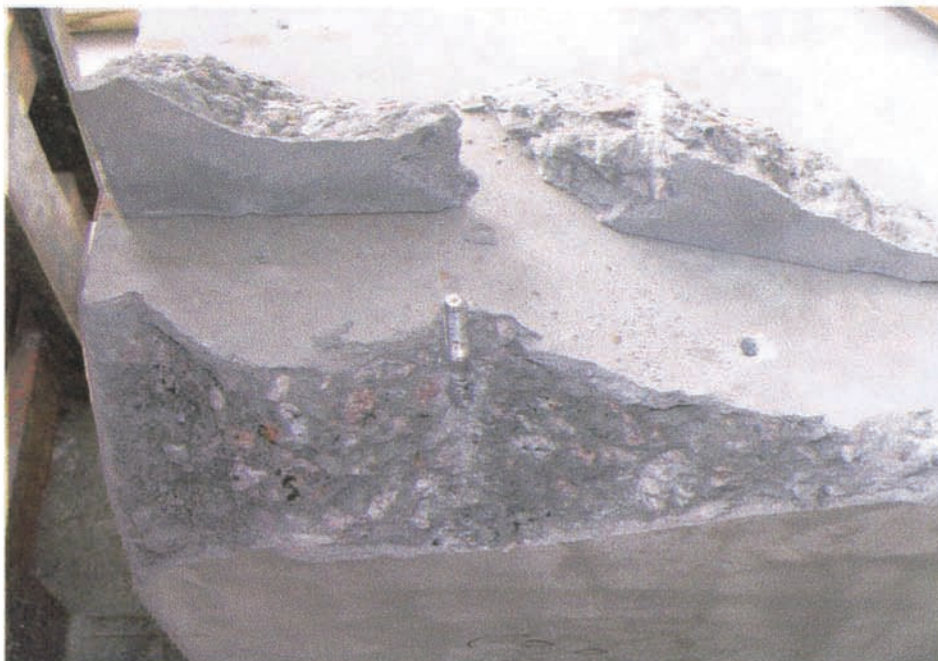
After Test
Sample I.D. : ST90534/B56

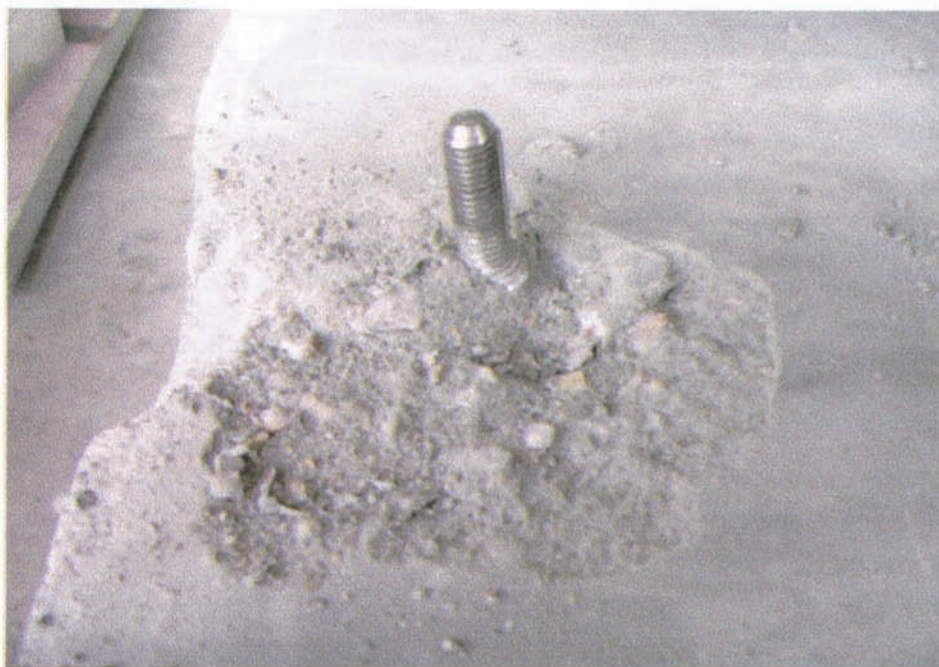
After Test
Sample I.D. : ST90534/B58

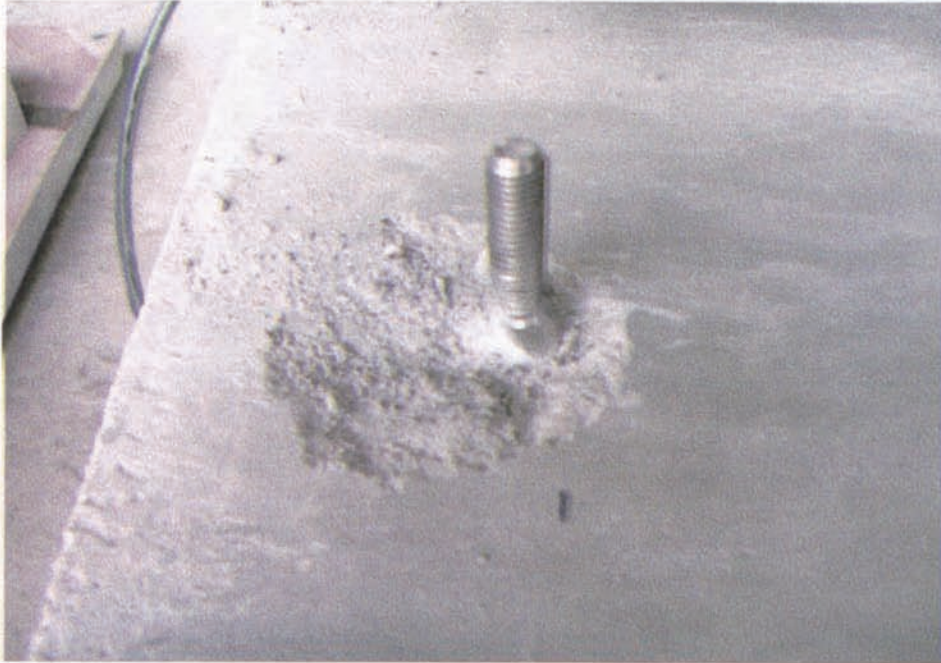
After Test
Sample I.D. : ST90534/B59

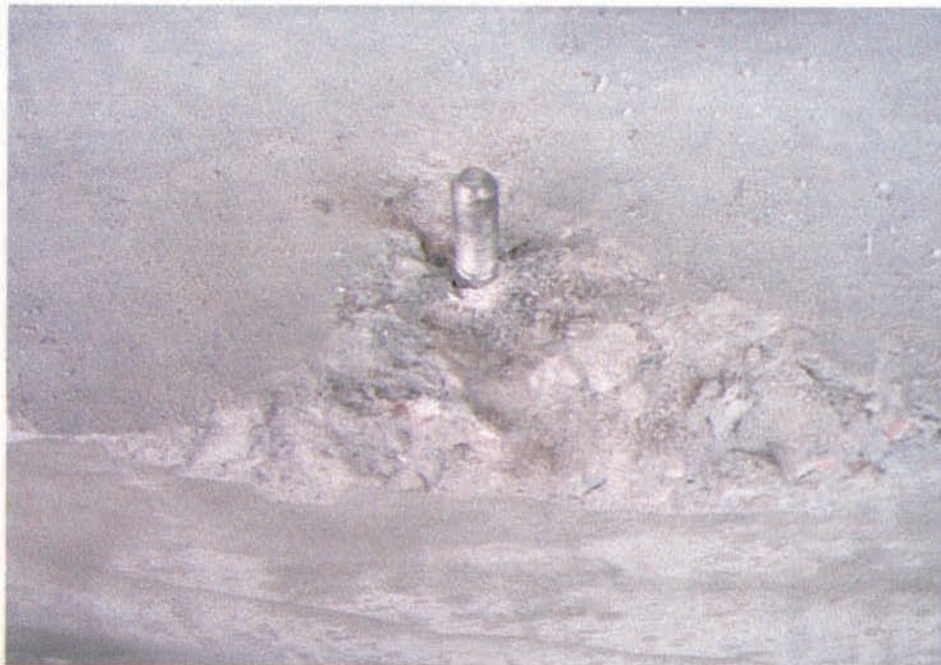
After Test
Sample I.D. : ST90534/B62

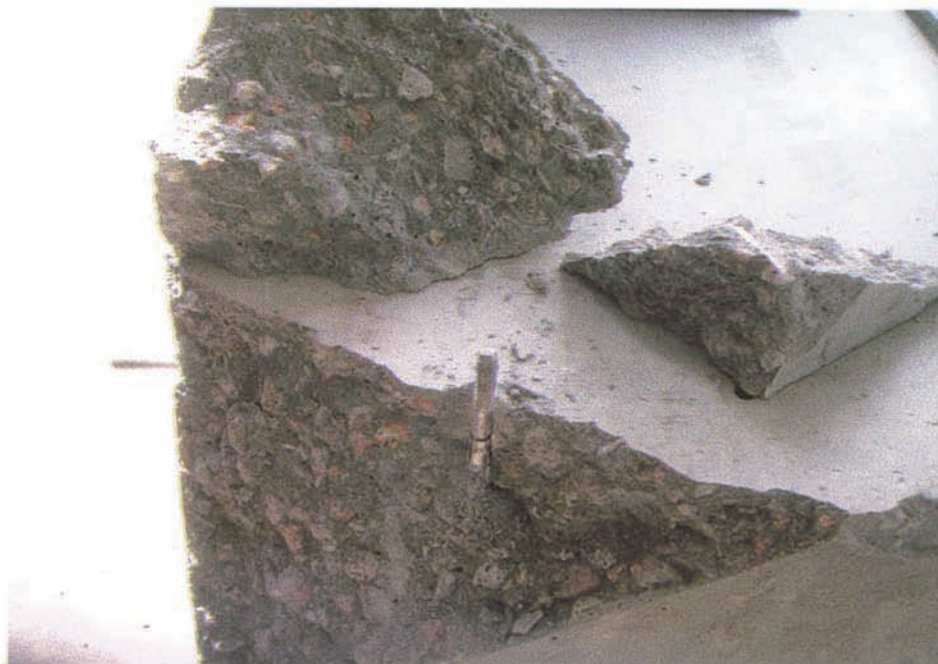
After Test
Sample I.D. : ST90534/B63

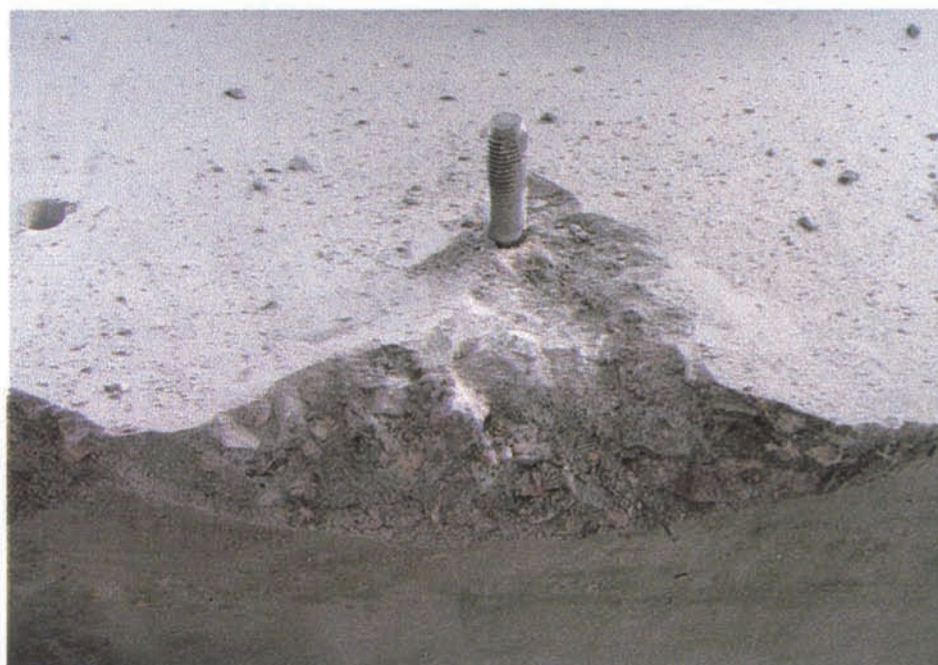
After Test
Sample I.D. : ST90534/B64

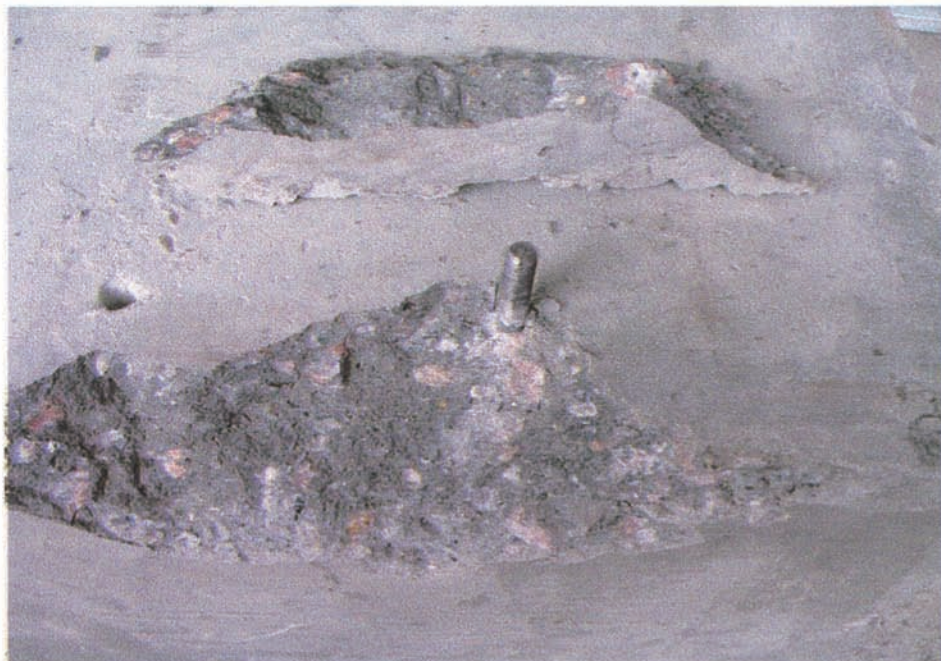
After Test
Sample I.D. : ST90534/B68

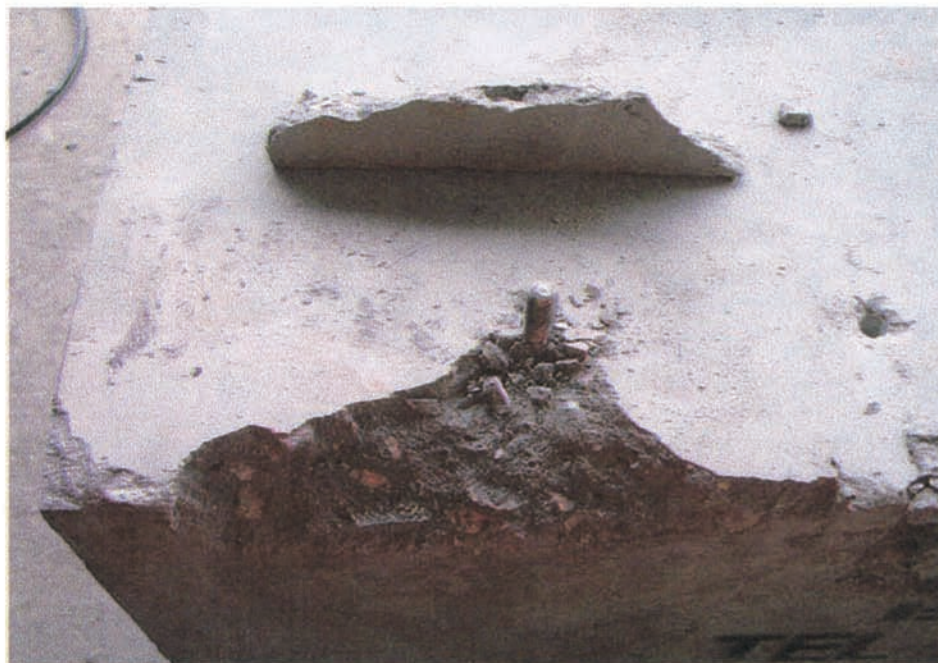
After Test
Sample I.D. : ST90534/B69

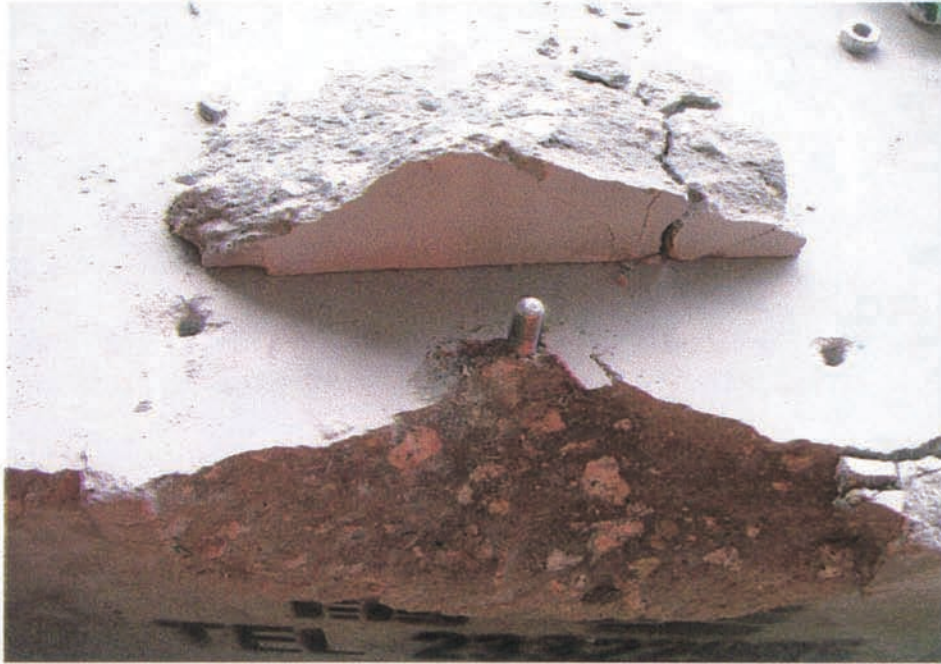
After Test
Sample I.D. : ST90534/B70

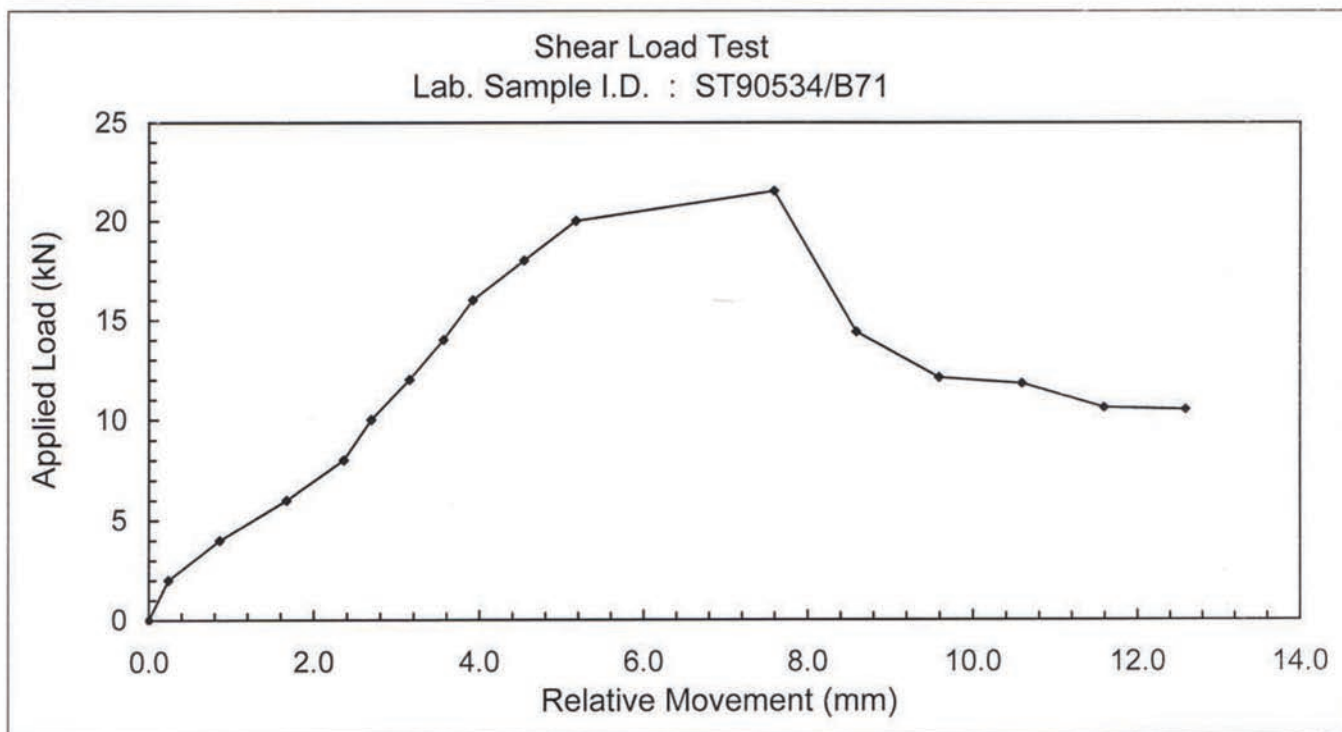
Applied Load (kN)	Relative Movement (mm)	Applied Load (kN)	Relative Movement (mm)
0	0	18.0	4.54
2.0	0.24	20.0	5.17
4.0	0.86	21.5	7.59
6.0	1.67	14.4	8.59
8.0	2.36	12.1	9.59
10.0	2.69	11.8	10.59
12.0	3.15	10.6	11.59
14.0	3.56	10.5	12.59
16.0	3.92

Observation: Failure of concrete & deformation of anchor bolt was noted at the applied load of 21.5 kN.
