REPORT ON SHEAR STRENGTH TEST OF E10 ANCHOR BOLT EMBEDDED IN NON-CRACKED CONCRETE

REPORT ON THE SHEAR LOAD TEST OF ANCHOR BOLT

Project : Testing of Anchor Bolt SW-E10

Report No. : 092660ST90534(1)

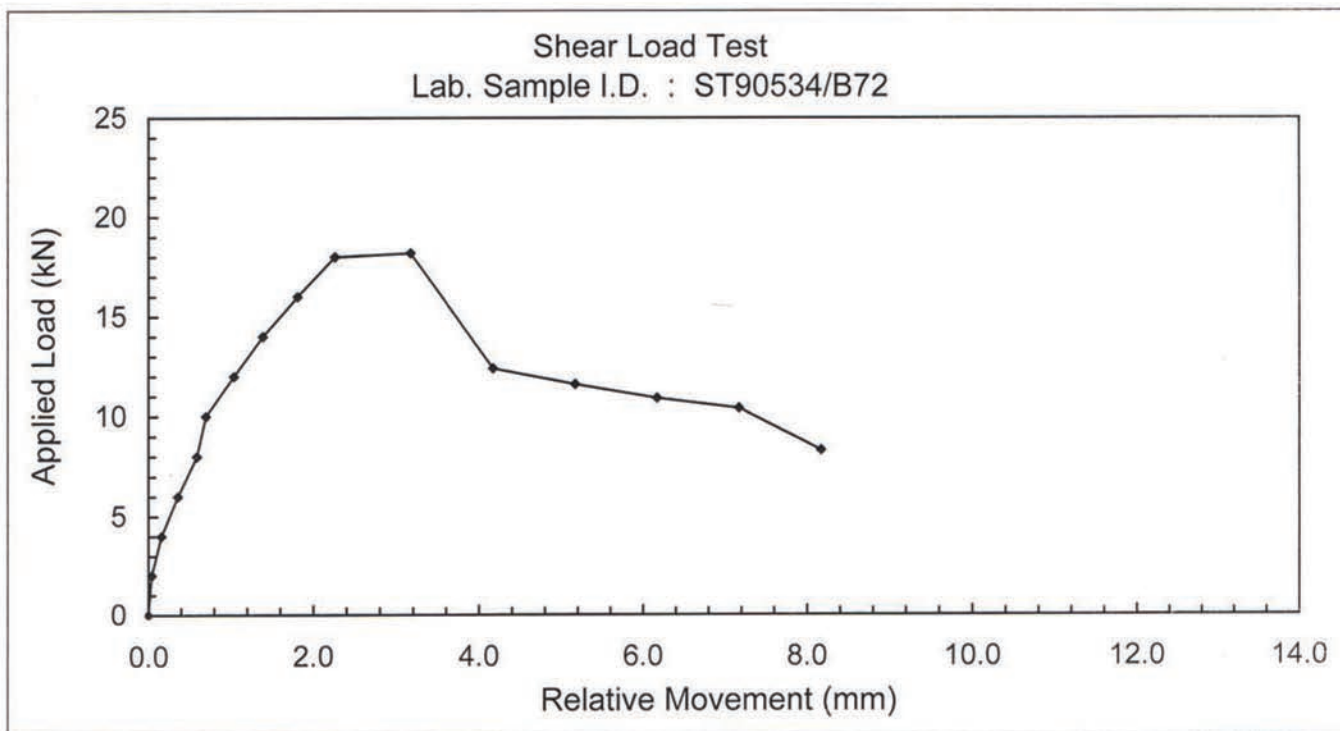
Applied Load (kN)	Relative Movement (mm)	Applied Load (kN)	Relative Movement (mm)
0	0	16.0	1.81
2.0	0.04	18.0	2.26
4.0	0.16	18.2	3.17
6.0	0.36	12.4	4.17
8.0	0.59	11.6	5.17
10.0	0.70	10.9	6.17
12.0	1.04	10.4	7.17
14.0	1.39	8.3	8.17

Observation: Failure of concrete & deformation of anchor bolt was noted at the applied load of 18.2 kN.

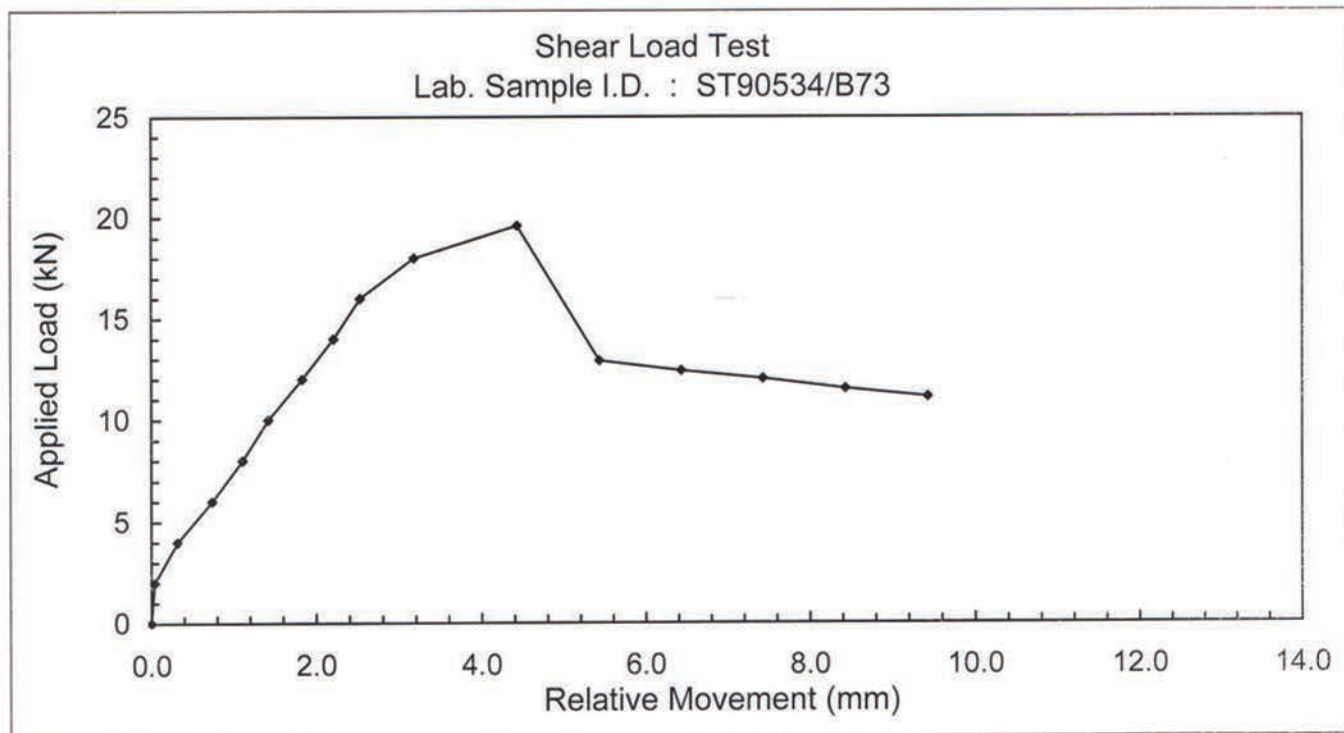
Applied Load (kN)	Relative Movement (mm)	Applied Load (kN)	Relative Movement (mm)
0	0	16.0	2.53
2.0	0.04	18.0	3.18
4.0	0.32	19.6	4.43
6.0	0.74	12.9	5.43
8.0	1.11	12.4	6.43
10.0	1.42	12.0	7.43
12.0	1.83	11.5	8.43
14.0	2.21	11.1	9.43

Observation: Failure of concrete & deformation of anchor bolt was noted at the applied load of 19.6 kN.

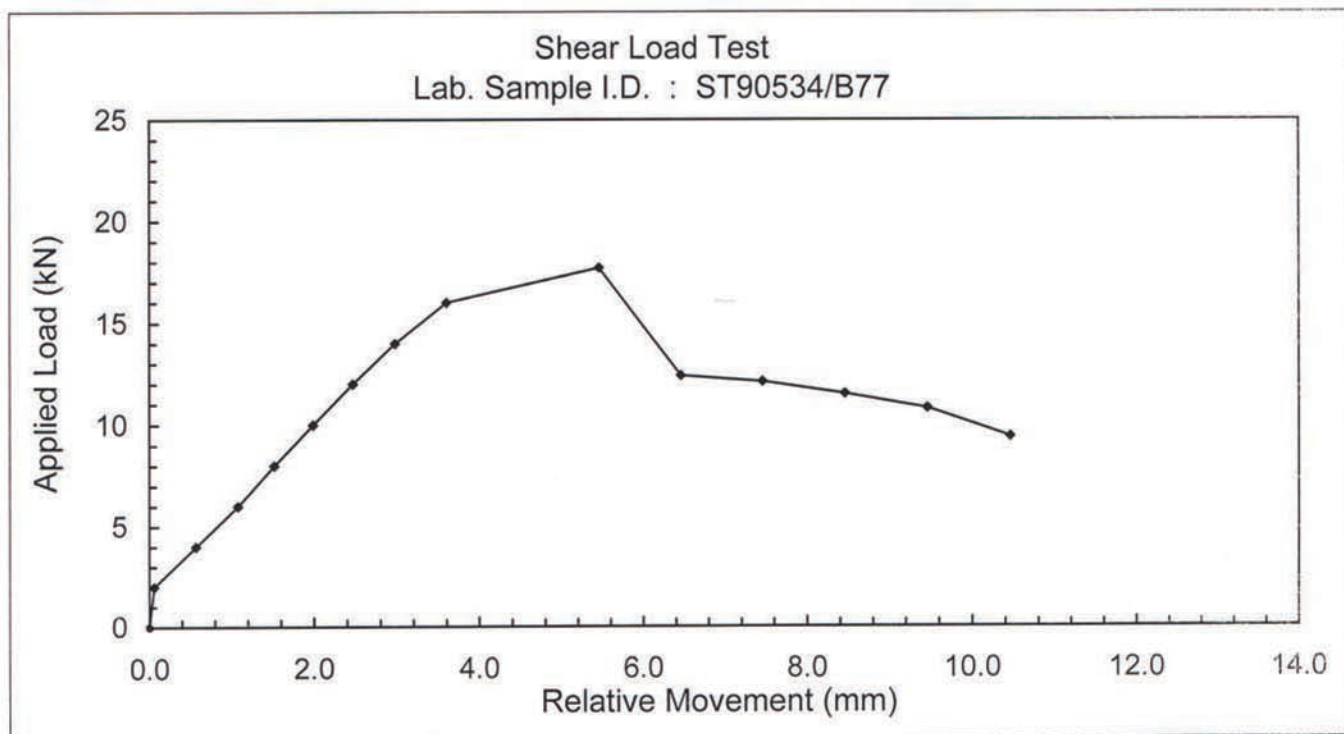
Applied Load (kN)	Relative Movement (mm)	Applied Load (kN)	Relative Movement (mm)
0	0	16.0	3.60
2.0	0.06	17.7	5.46
4.0	0.57	12.4	6.46
6.0	1.08	12.1	7.46
8.0	1.52	11.5	8.46
10.0	1.99	10.8	9.46
12.0	2.47	9.4	10.46
14.0	2.98

Observation: Failure of concrete & deformation of anchor bolt was noted at the applied load of 17.7 kN.

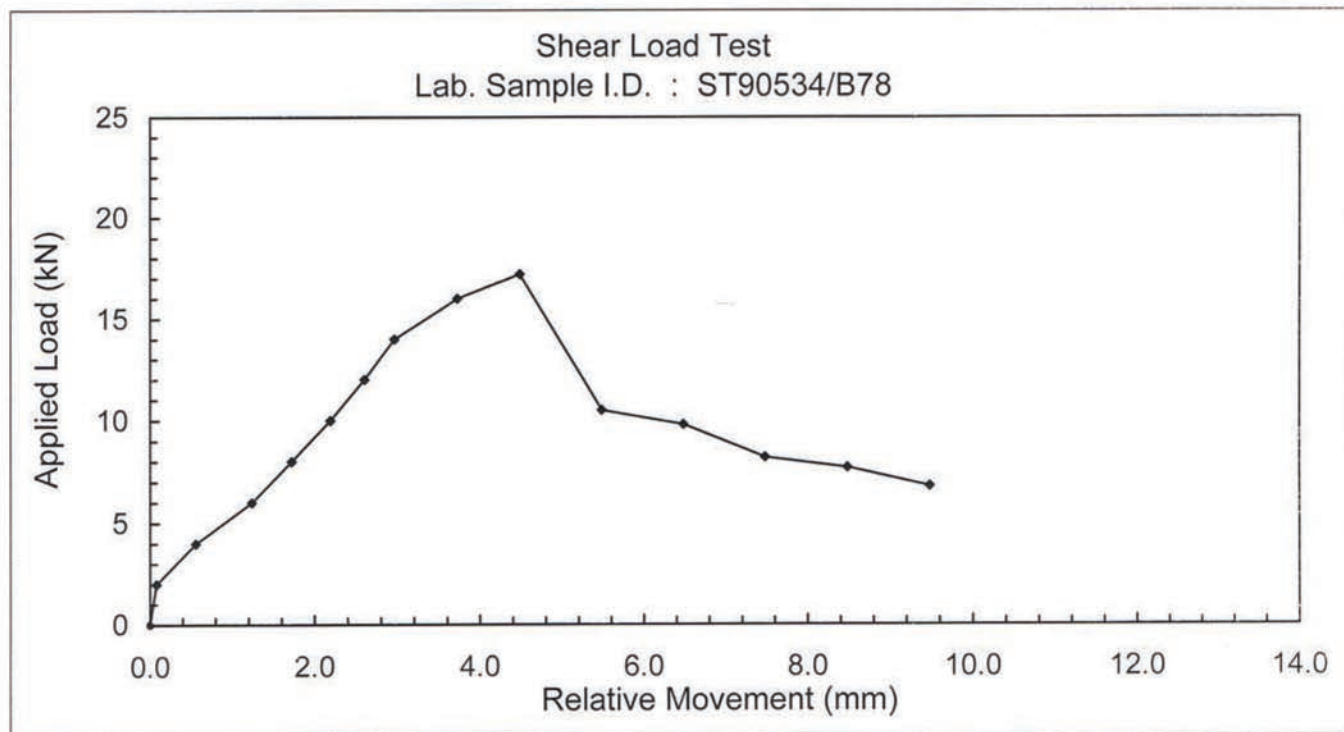
Applied Load (kN)	Relative Movement (mm)	Applied Load (kN)	Relative Movement (mm)
0	0	16.0	3.72
2.0	0.08	17.2	4.48
4.0	0.56	10.5	5.48
6.0	1.24	9.8	6.48
8.0	1.72	8.2	7.48
10.0	2.19	7.7	8.48
12.0	2.60	6.8	9.48
14.0	2.96

Observation: Failure of concrete & deformation of anchor bolt was noted at the applied load of 17.2 kN.

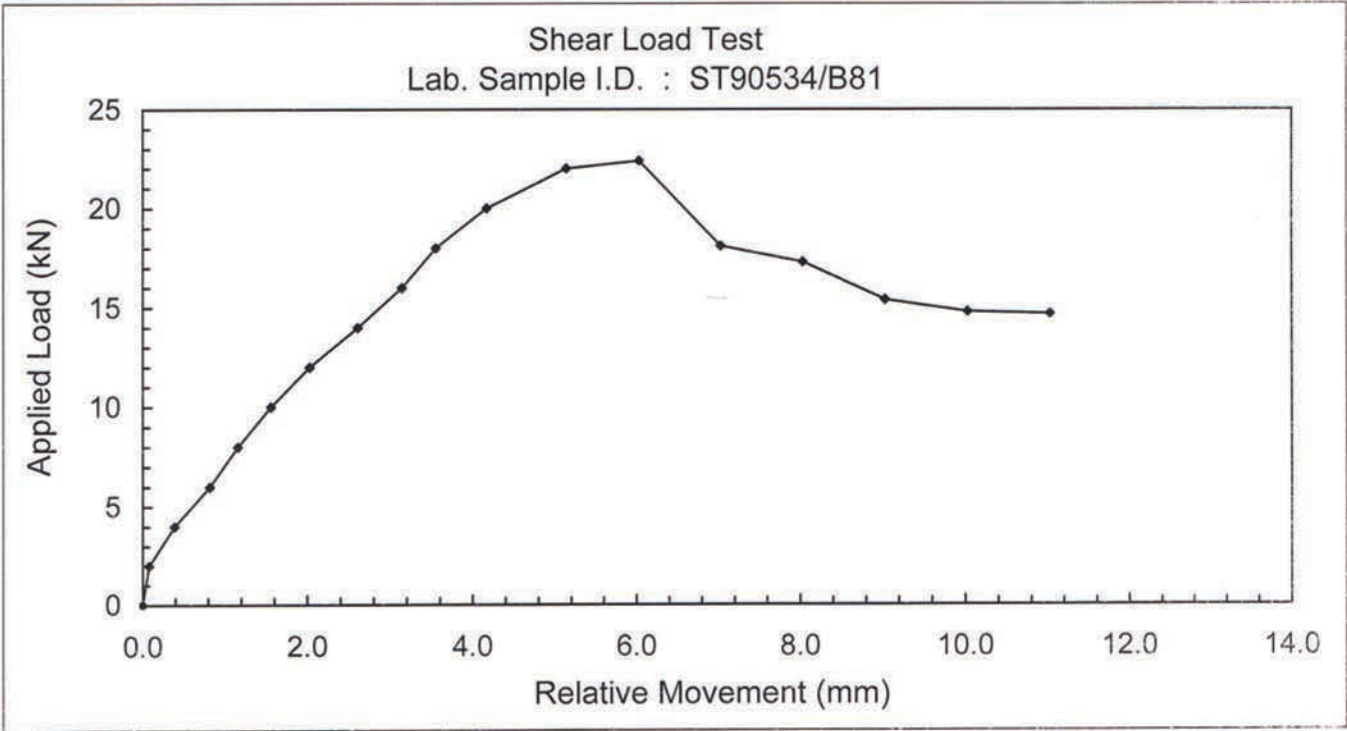
Lab. Sample I.D. : ST90534/B81 Date Tested : 20 February 2010

Applied Load (kN)	Relative Movement (mm)	Applied Load (kN)	Relative Movement (mm)
0	0	18.0	3.55
2.0	0.08	20.0	4.17
4.0	0.39	22.0	5.14
6.0	0.82	22.4	6.03
8.0	1.16	18.1	7.03
10.0	1.56	17.3	8.03
12.0	2.03	15.4	9.03
14.0	2.61	14.8	10.03
16.0	3.14	14.7	11.03

Observation: Failure of concrete & deformation of anchor bolt was noted at the applied load of 22.4 kN.

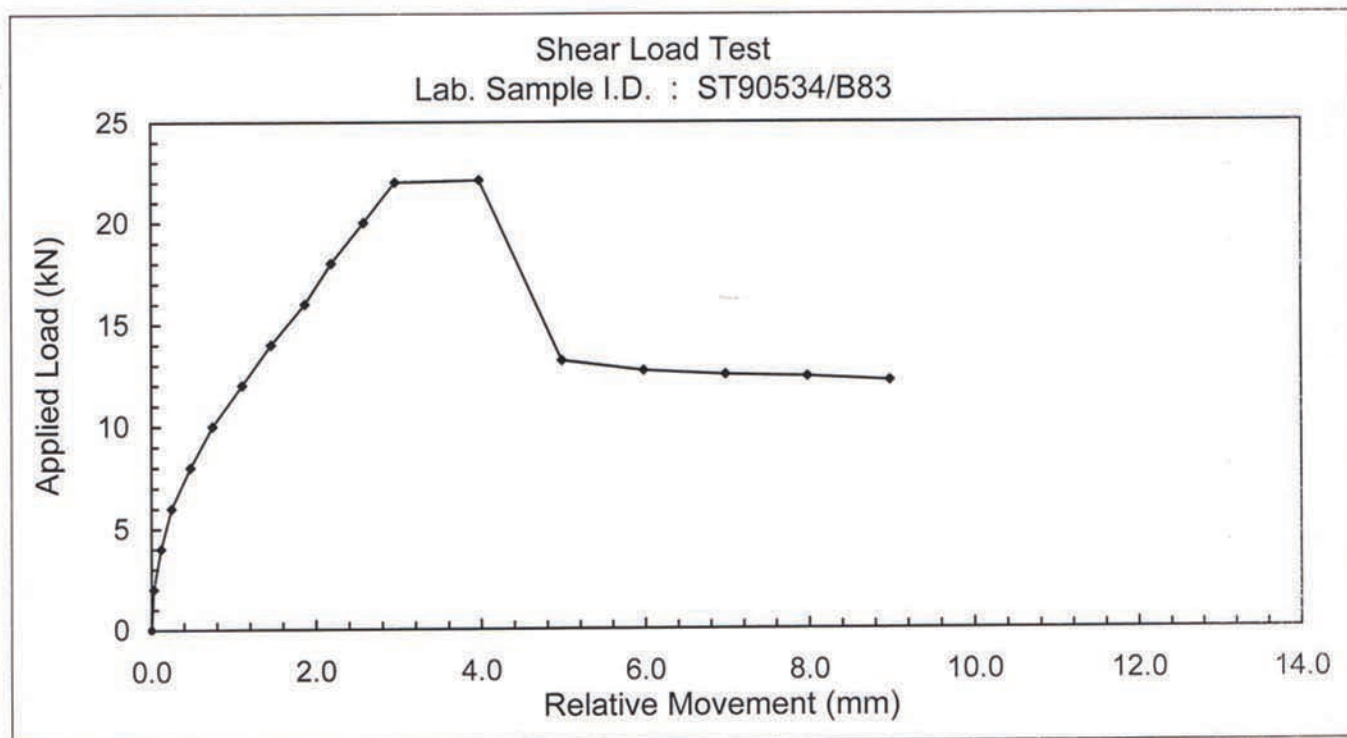
Applied Load (kN)	Relative Movement (mm)	Applied Load (kN)	Relative Movement (mm)
0	0	18.0	2.19
2.0	0.03	20.0	2.58
4.0	0.12	22.0	2.96
6.0	0.25	22.1	3.98
8.0	0.48	13.2	4.98
10.0	0.75	12.7	5.98
12.0	1.11	12.5	6.98
14.0	1.46	12.4	7.98
16.0	1.87	12.2	8.98

Observation: Failure of concrete & deformation of anchor bolt was noted at the applied load of 22.1 kN.

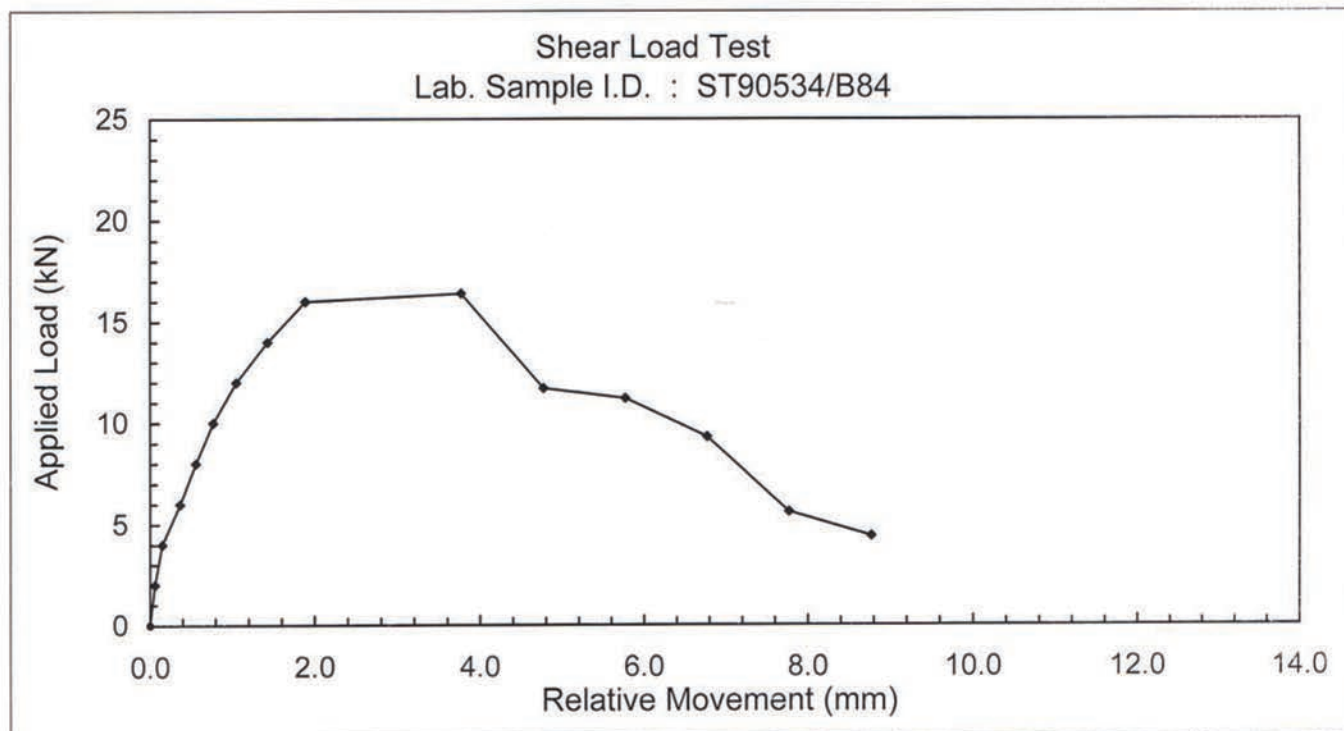
Applied Load (kN)	Relative Movement (mm)	Applied Load (kN)	Relative Movement (mm)
0	0	16.0	1.89
2.0	0.06	16.4	3.77
4.0	0.15	11.7	4.77
6.0	0.37	11.2	5.77
8.0	0.56	9.3	6.77
10.0	0.77	5.6	7.77
12.0	1.05	4.4	8.77
14.0	1.43

Observation: Failure of concrete & deformation of anchor bolt was noted at the applied load of 16.4 kN.

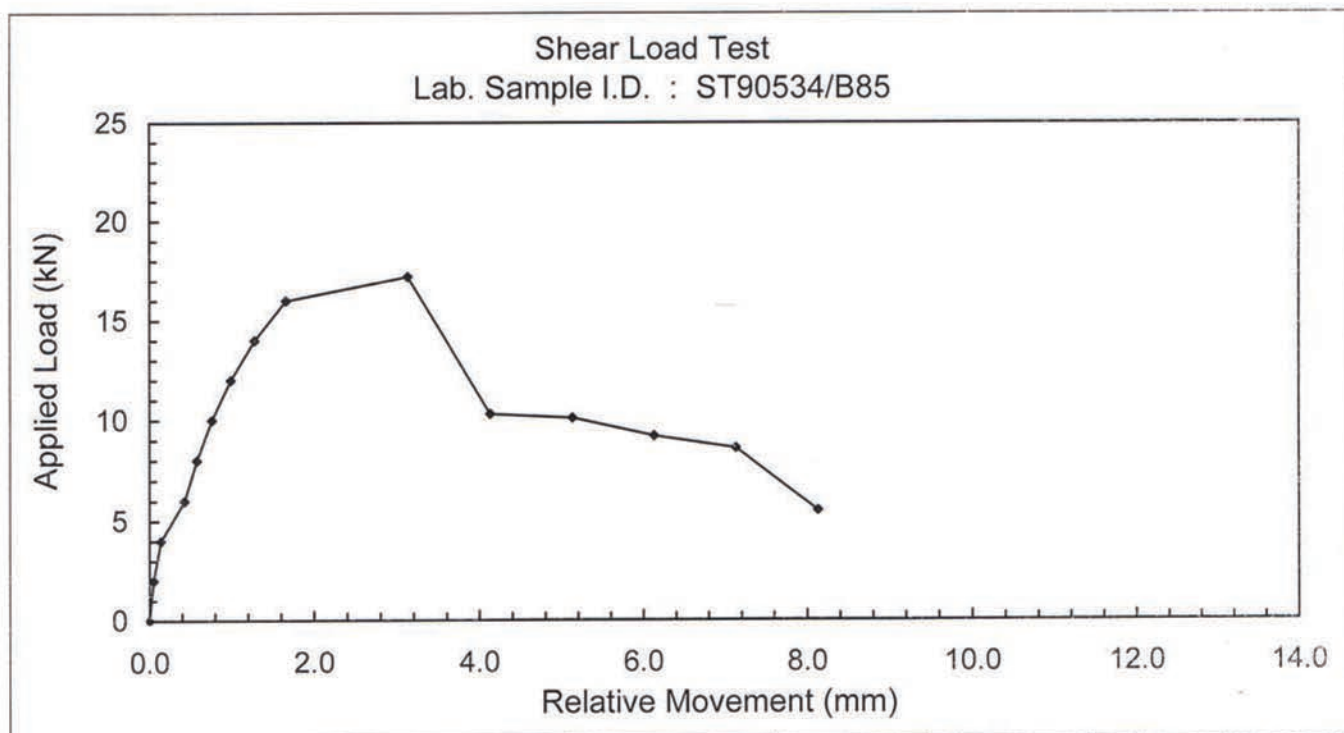
Applied Load (kN)	Relative Movement (mm)	Applied Load (kN)	Relative Movement (mm)
0	0	16.0	1.66
2.0	0.05	17.2	3.13
4.0	0.14	10.3	4.13
6.0	0.43	10.1	5.13
8.0	0.58	9.2	6.13
10.0	0.76	8.6	7.13
12.0	0.99	5.5	8.13
14.0	1.28

Observation: Failure of concrete & deformation of anchor bolt was noted at the applied load of 17.2 kN.

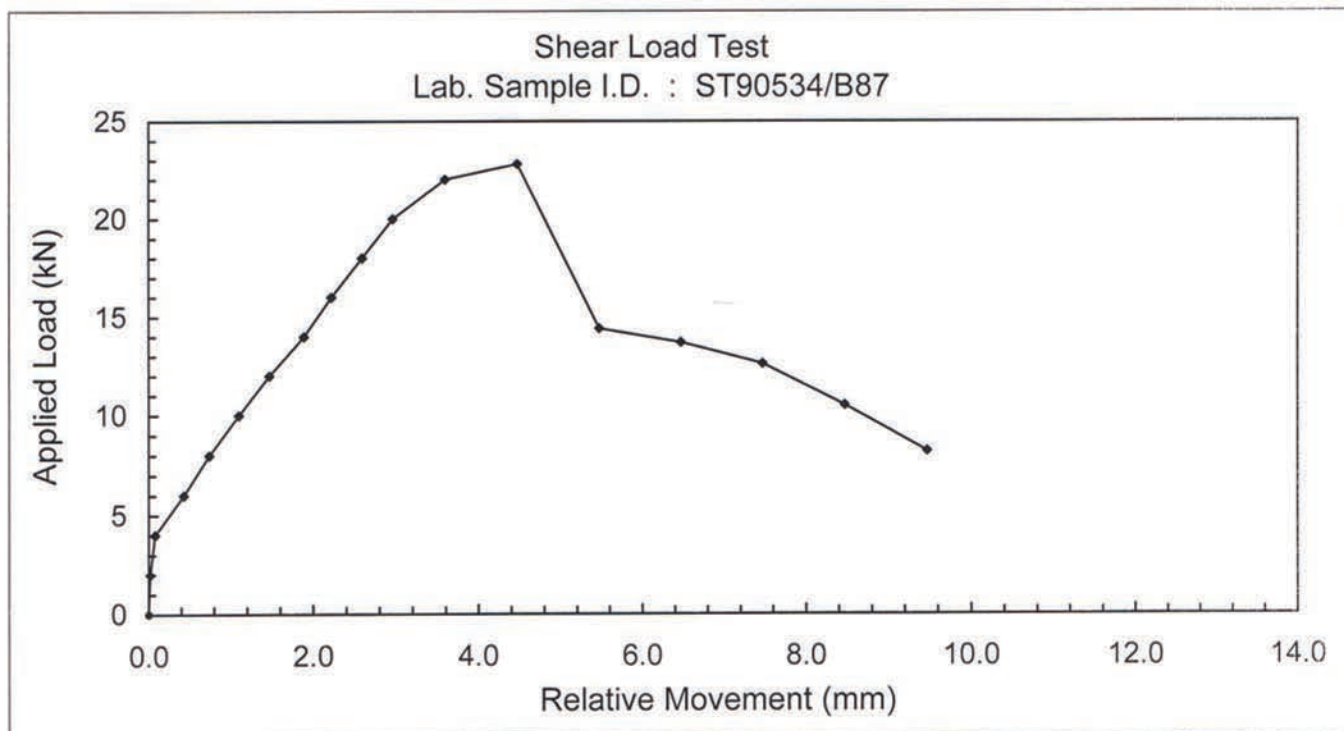
Applied Load (kN)	Relative Movement (mm)	Applied Load (kN)	Relative Movement (mm)
0	0	18.0	2.59
2.0	0.02	20.0	2.96
4.0	0.08	22.0	3.59
6.0	0.43	22.8	4.47
8.0	0.74	14.4	5.47
10.0	1.10	13.7	6.47
12.0	1.47	12.6	7.47
14.0	1.89	10.5	8.47
16.0	2.22	8.2	9.47

Observation: Failure of concrete & deformation of anchor bolt was noted at the applied load of 22.8 kN.

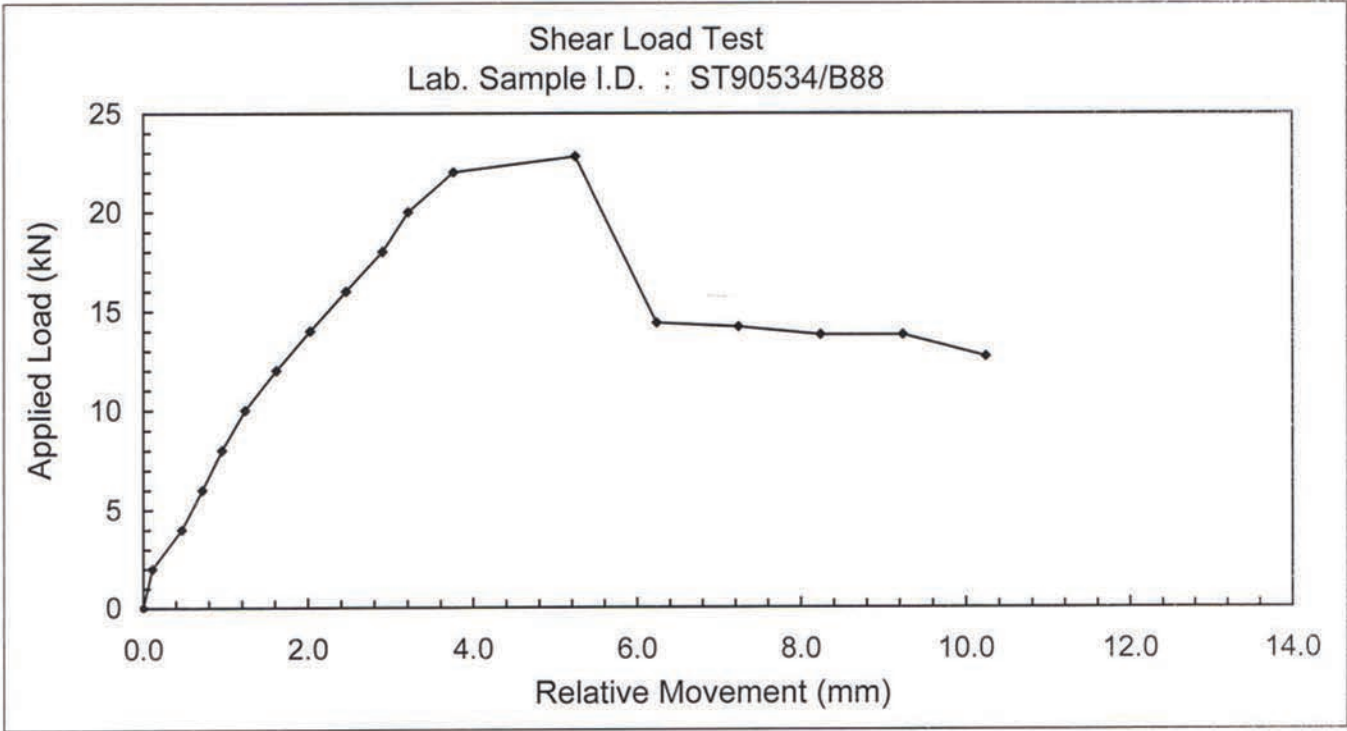
Lab. Sample I.D. : ST90534/B88 Date Tested : 21 February 2010

Applied Load (kN)	Relative Movement (mm)	Applied Load (kN)	Relative Movement (mm)
0	0	18.0	2.90
2.0	0.11	20.0	3.21
4.0	0.47	22.0	3.76
6.0	0.72	22.8	5.24
8.0	0.96	14.4	6.24
10.0	1.24	14.2	7.24
12.0	1.62	13.8	8.24
14.0	2.03	13.8	9.24
16.0	2.46	12.7	10.24

Observation: Failure of concrete & deformation of anchor bolt was noted at the applied load of 22.8 kN.

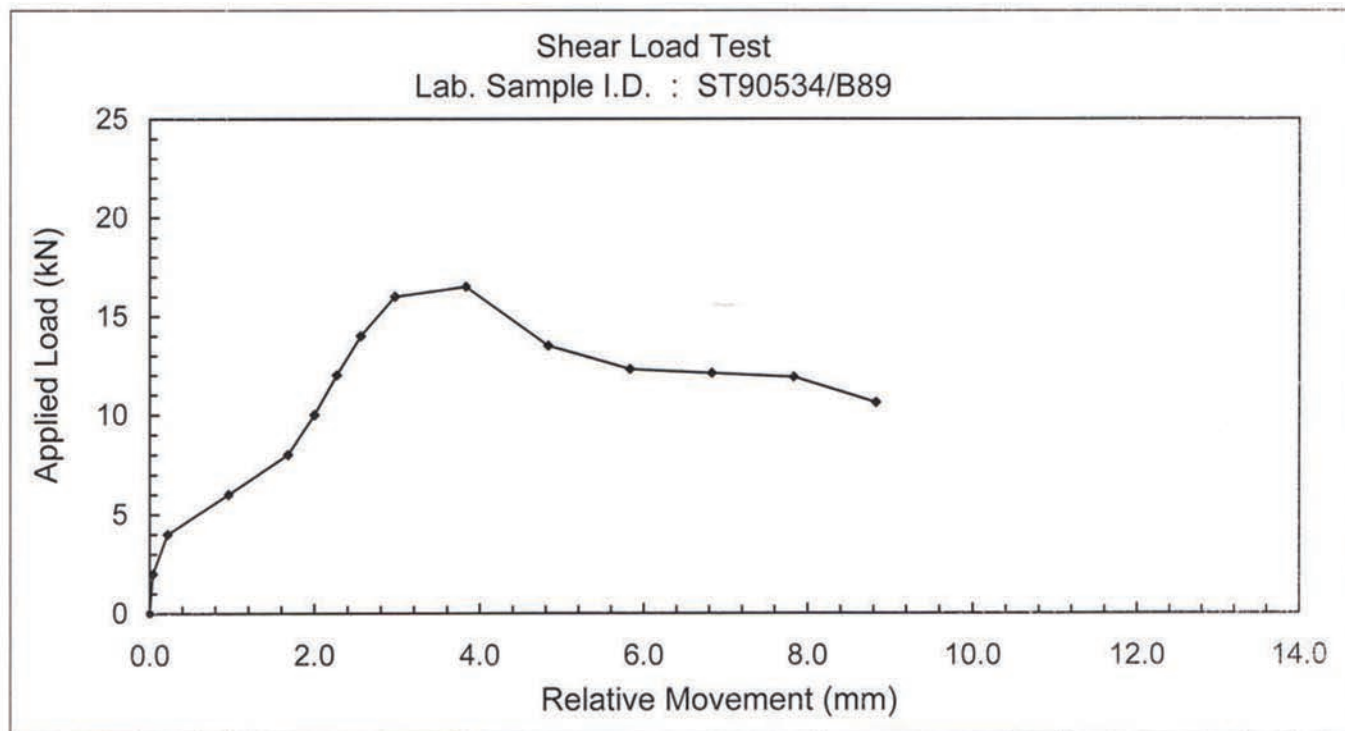
Lab. Sample I.D. : ST90534/B89

Applied Load (kN)	Relative Movement (mm)	Applied Load (kN)	Relative Movement (mm)
0	0	16.0	2.97
2.0	0.04	16.5	3.83
4.0	0.22	13.5	4.83
6.0	0.96	12.3	5.83
8.0	1.68	12.1	6.83
10.0	2.00	11.9	7.83
12.0	2.27	10.6	8.83
14.0	2.56

Observation: Failure of concrete & deformation of anchor bolt was noted at the applied load of 16.5 kN.
